**NATIONAL REGISTER OF HISTORIC PLACES
INVENTORY -- NOMINATION FORM**

AND/OR COMMON
Union Creek Historic District

Union Creek Historic District
Jackson County, Oregon
FEATURE LOCATION MAP

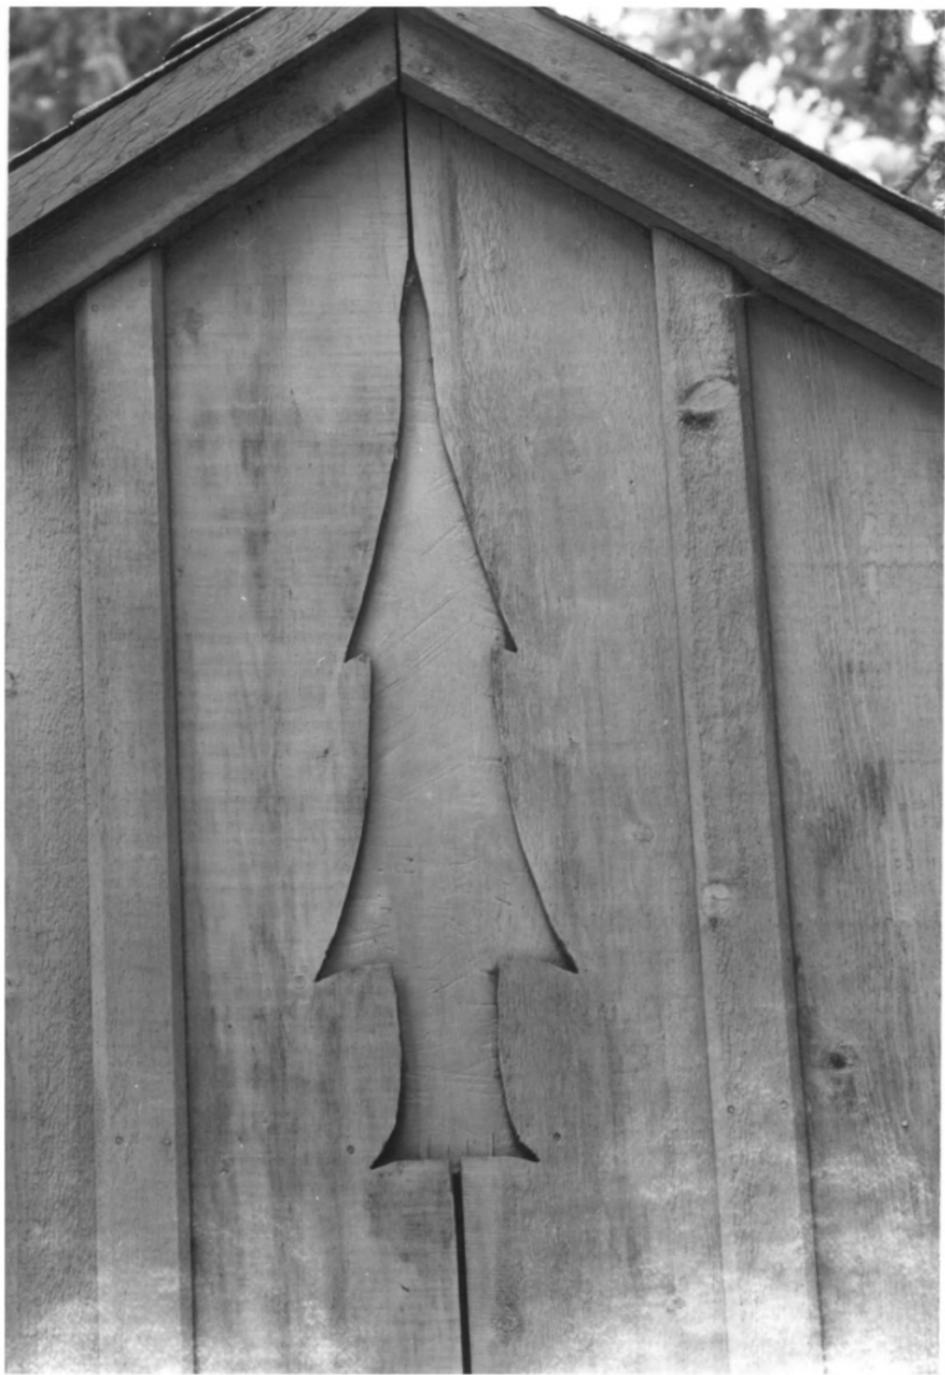
Detail of Pine Tree Cut Out
Union Creek Historic District
Vicinity - Prospect, Oregon
Photographer: G.J. Throop 1/79
Negative in CRM Files - Recreation
S0 - Rogue River National Forest
Looking north toward the south gable end.

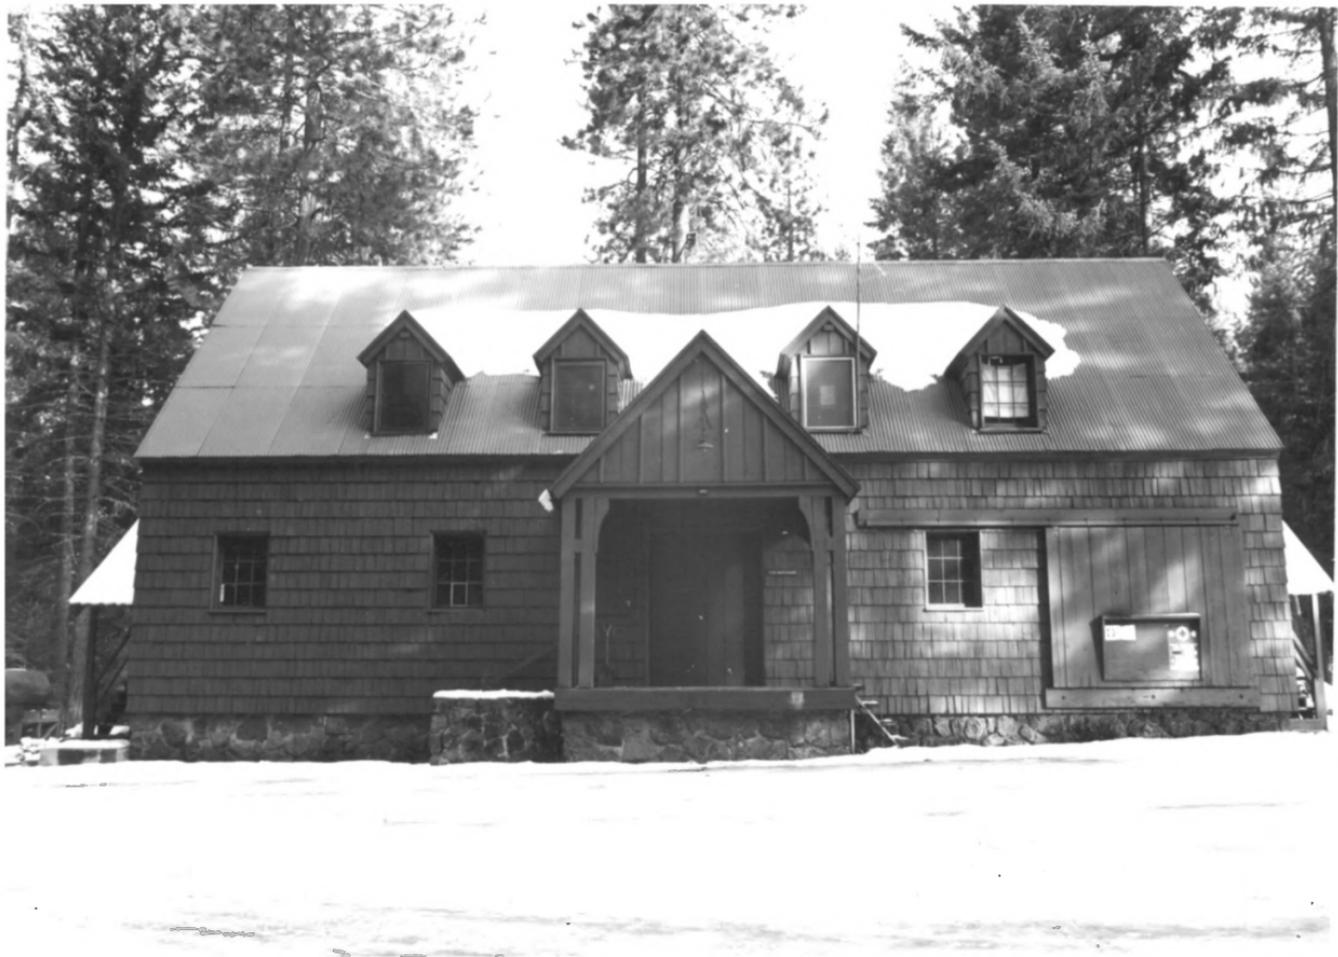
Fire Warehouse #2205
Union Creek Historic District
Vicinity - Prospect, Oregon

Photographer: G.J. Throop 1/79
Negative in CRM Files - Recreation
S0 - Rogue River National Forest
Looking north toward the south (main) facade.

40. Fire Warehouse #2205: 1934 - CCC, rectangular, two-story, heavy timber construction on lava rock foundation, high gable roof with gabled and shed roofed dormers. Exterior wood shingles and vertical board and batten, multi-light sash windows, covered porch on south facade, pine tree logo on porch pediment. 1946, second story converted to residential apartments, outside stairs added. 1959, stairs rebuilt, gabled porches added. 1962-63, wood shake roof replaced with corrugated metal, stairs covered with sloping metal roofs. Exterior of structure retains much of its architectural integrity despite alterations, in very good condition.

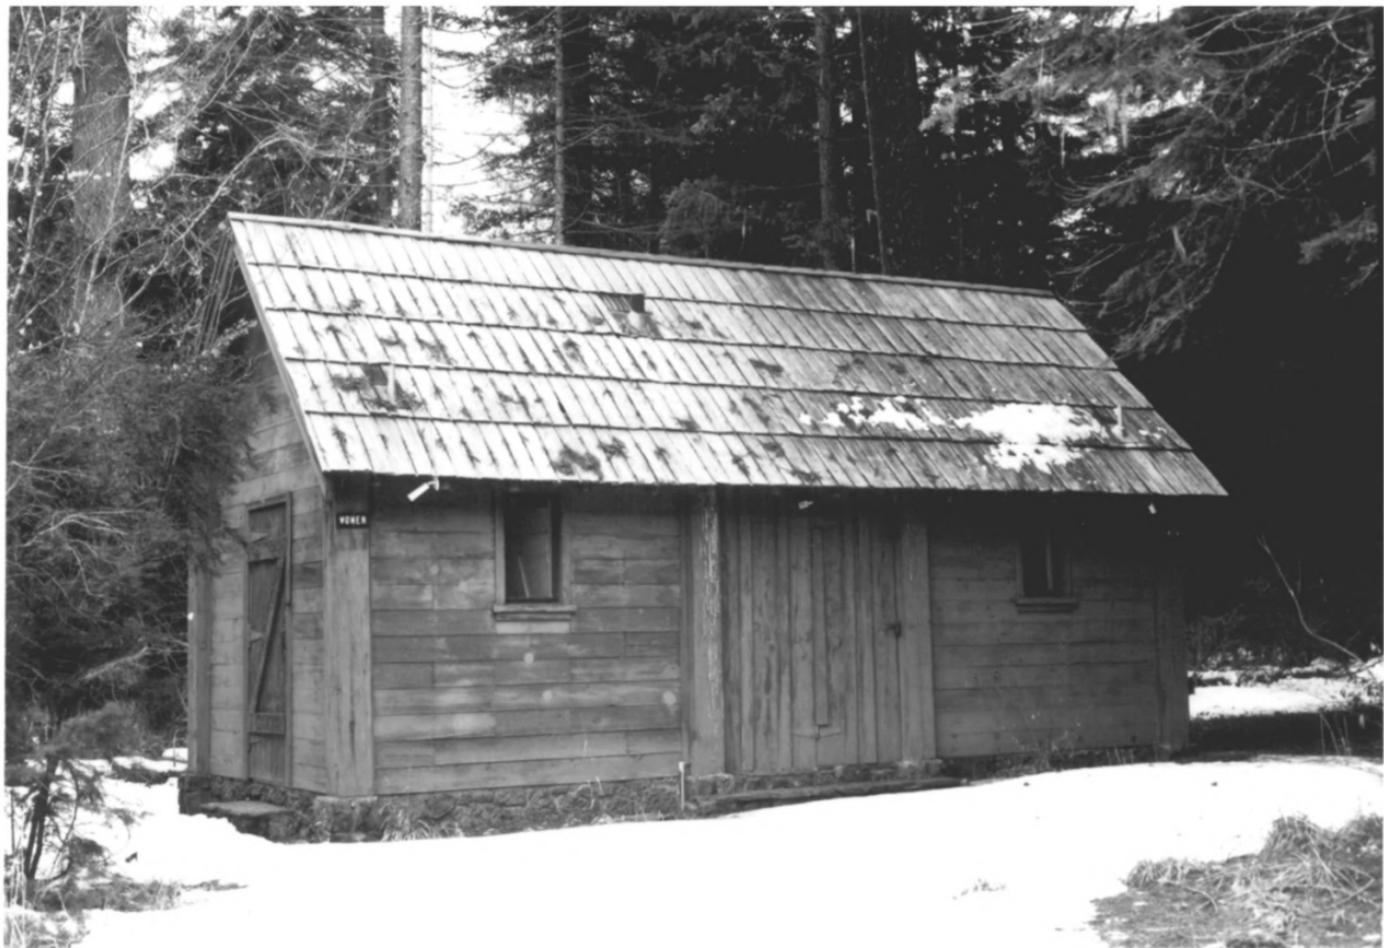
Registry Booth-Toilet Facility
Union Creek Historic District
Vicinity - Prospect, Oregon

47. Registry Booth - Comfort Station: 1935 - CCC, rectangular, post-on-sill construction of half-logs, originally bark-covered. 1956, a cement foundation was placed beneath structure. In very good condition, little altered.

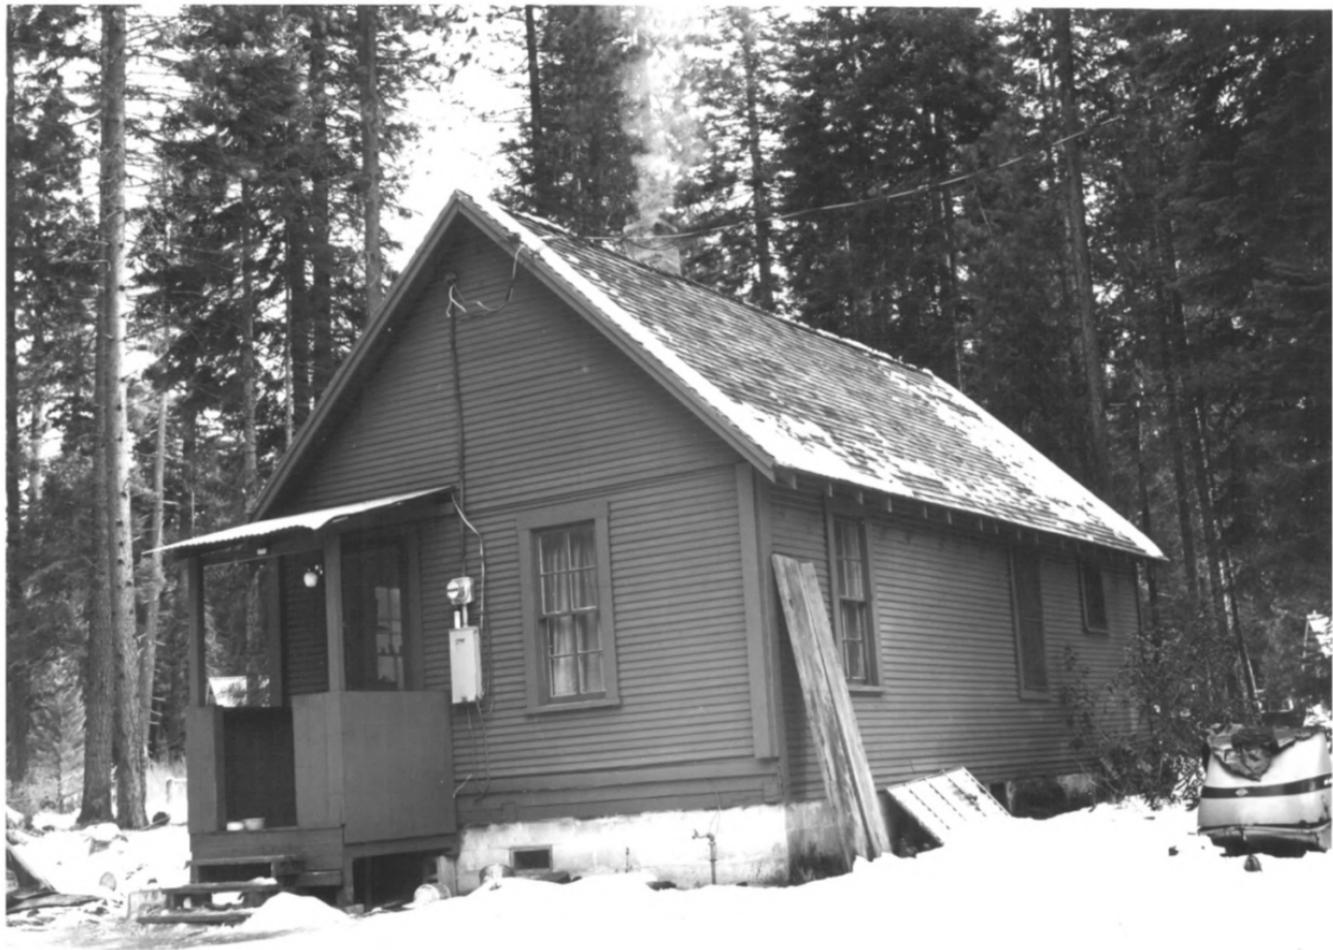
Forest Service Residence #1035
Union Creek Historic District
Vicinity - Prospect, Oregon

33. Forest Service Residence #1035: 1927, rectangular, single story, wood frame, cement block foundation, high gable roof, exterior narrow, rounded shiplap, multi-light sash windows. Formerly Hamaker Meadows Guard Station, was removed to present site in 1955. Lacking integrity of location, no obvious exterior alteration.

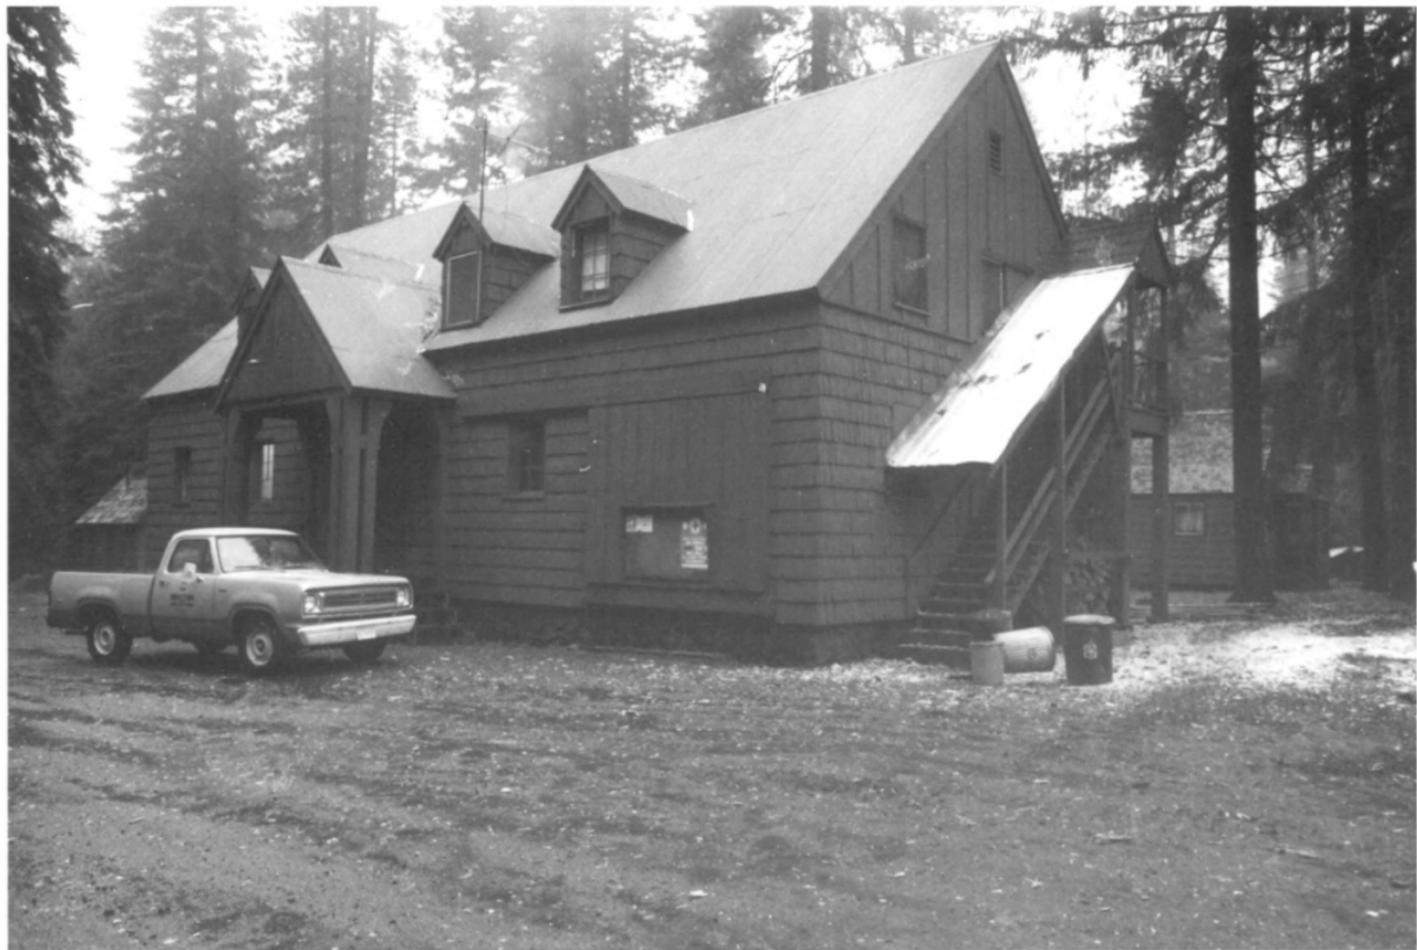
Fire Warehouse #2205
Union Creek Historic District
Vicinity - Prospect, Oregon
Photographer: E.G. Throop 11/78
Negative in CRM Files - Recreation
S0 - Rogue River National Forest

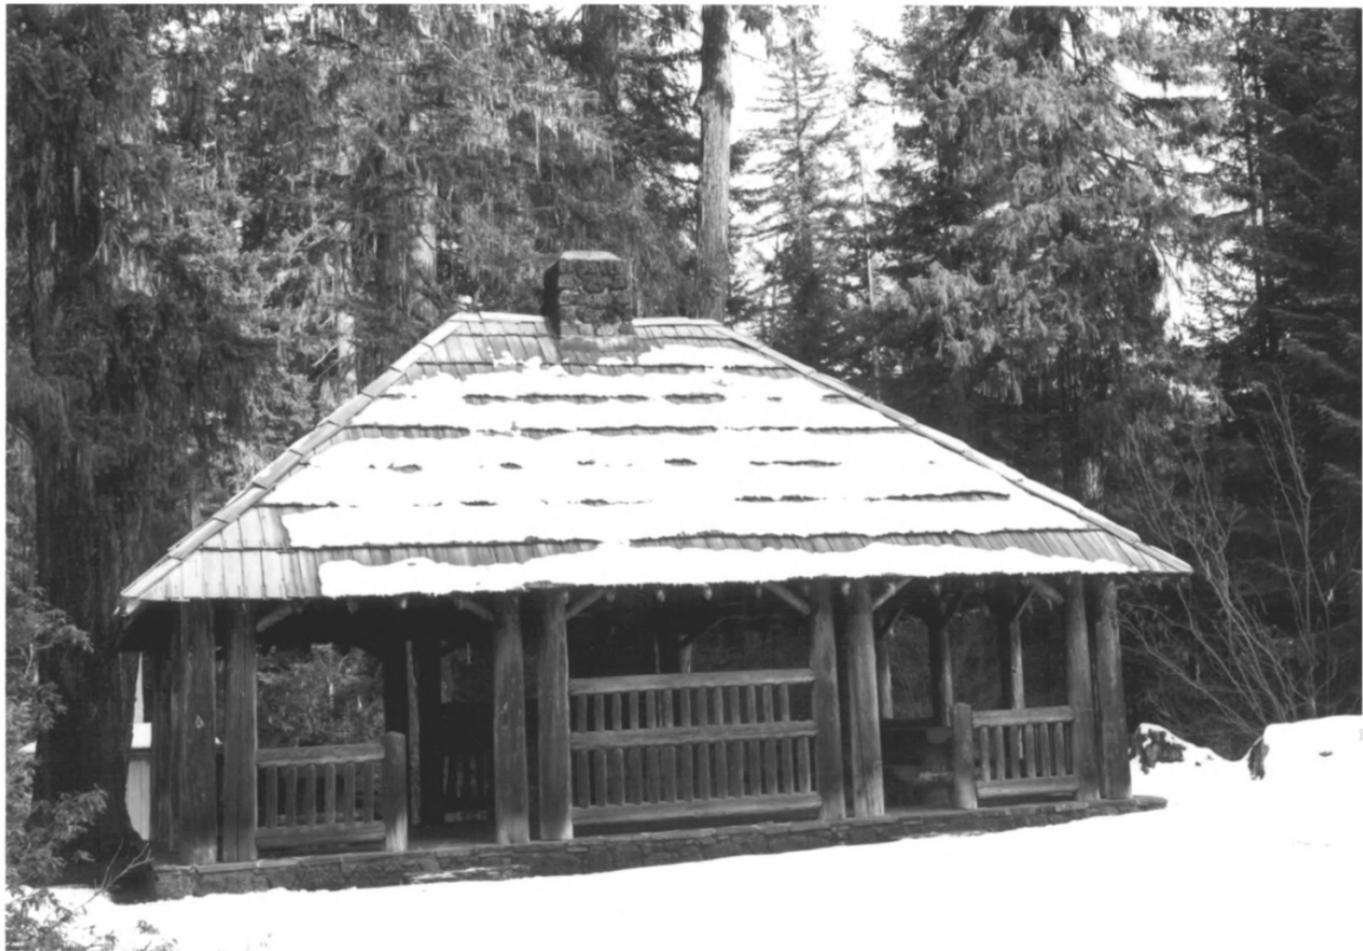
Community Kitchen
Union Creek Historic District
Vicinity - Prospect, Oregon

Photographer: G.J. Throop 1/79
Negative in CRM Files - Recreation
S.O. - Rogue River National Forest
Looking north toward south elevation of Community
Kitchen.

46. Community Kitchen: 1935 - CCC, rectangular (20x30) heavy peeled-log construction on raised lava rock platform, high hipped roof, central stone chimney, four stoves, wet sink with drainboard, four half-log picnic tables. Railing of horizontal peeled logs with smaller vertical peeled uprights. Sugar pine shake roof replaced 1978, with like materials, end-nailed as original. Excellent condition.

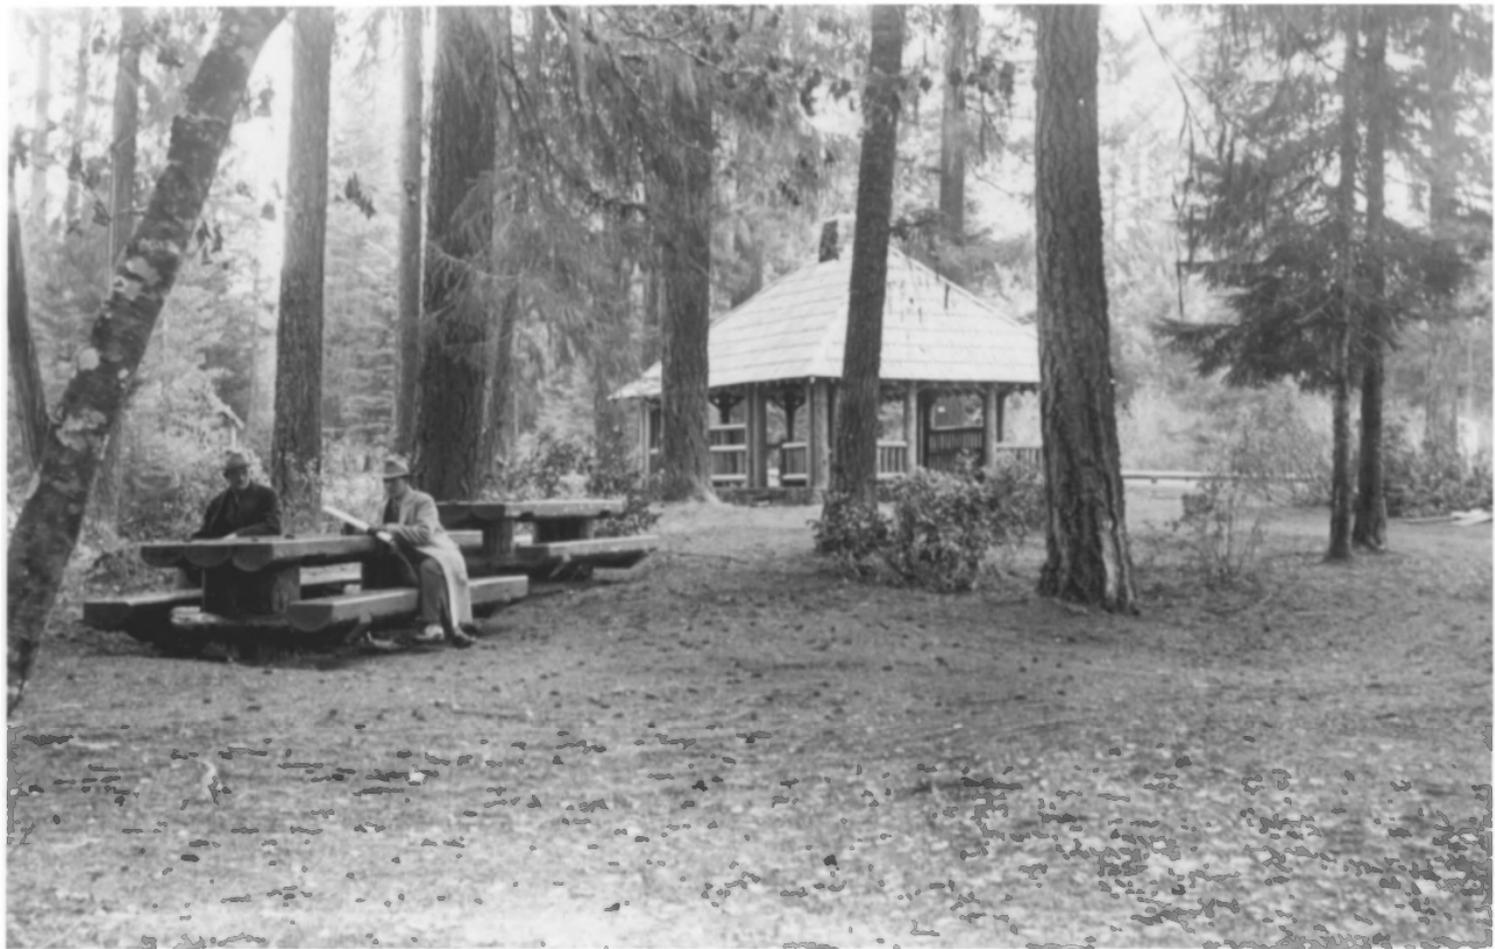
Community Kitchen in 1936
Union Creek Historic District
Vicinity - Prospect, Oregon
Photographer unknown 1936

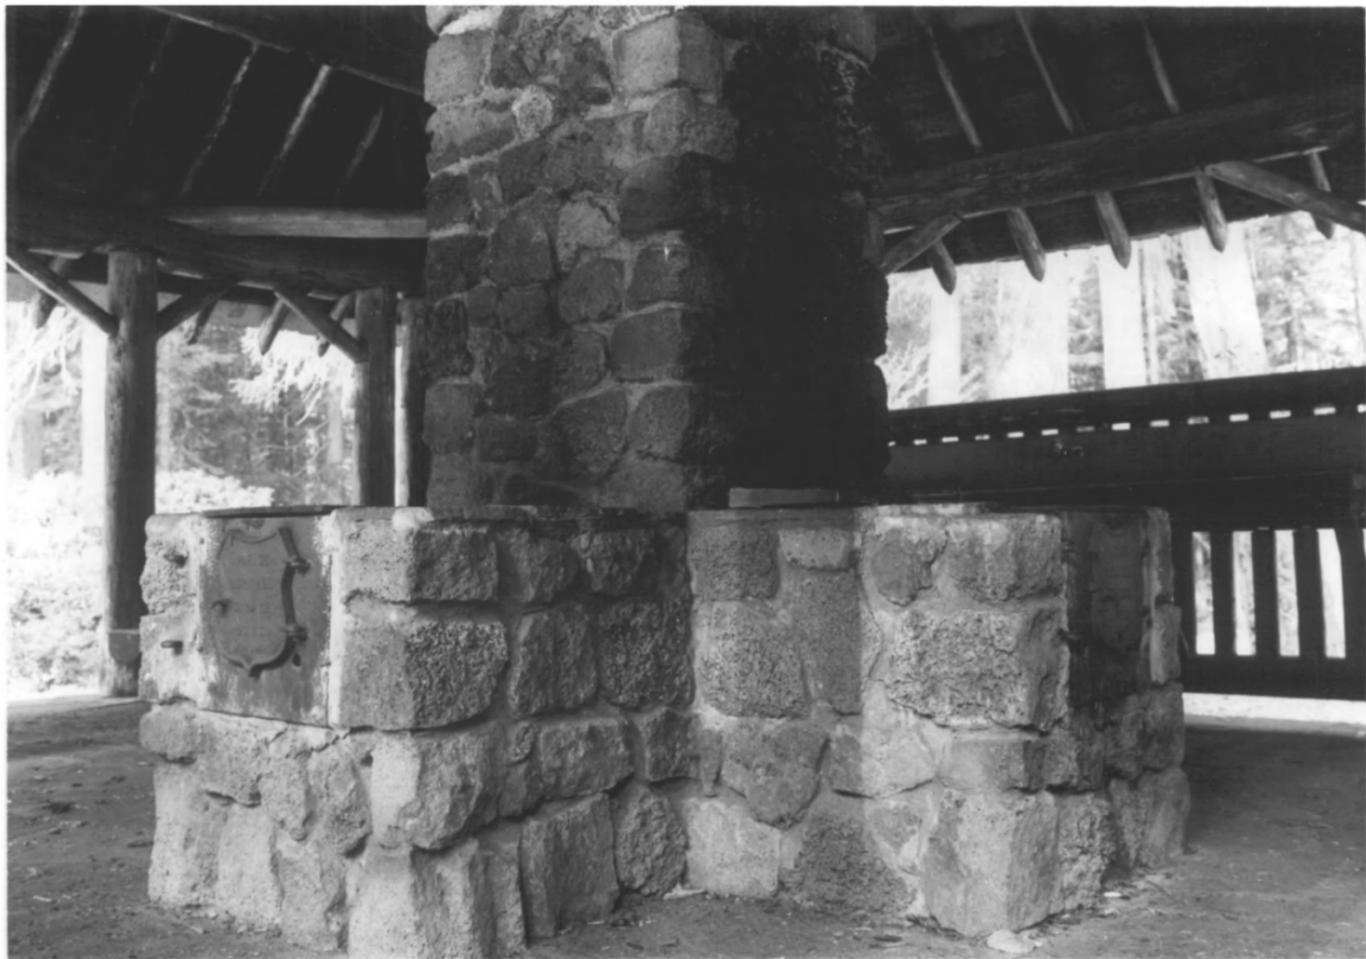
Detail of Stone Fireplaces and Central Chimney of
Community Kitchen

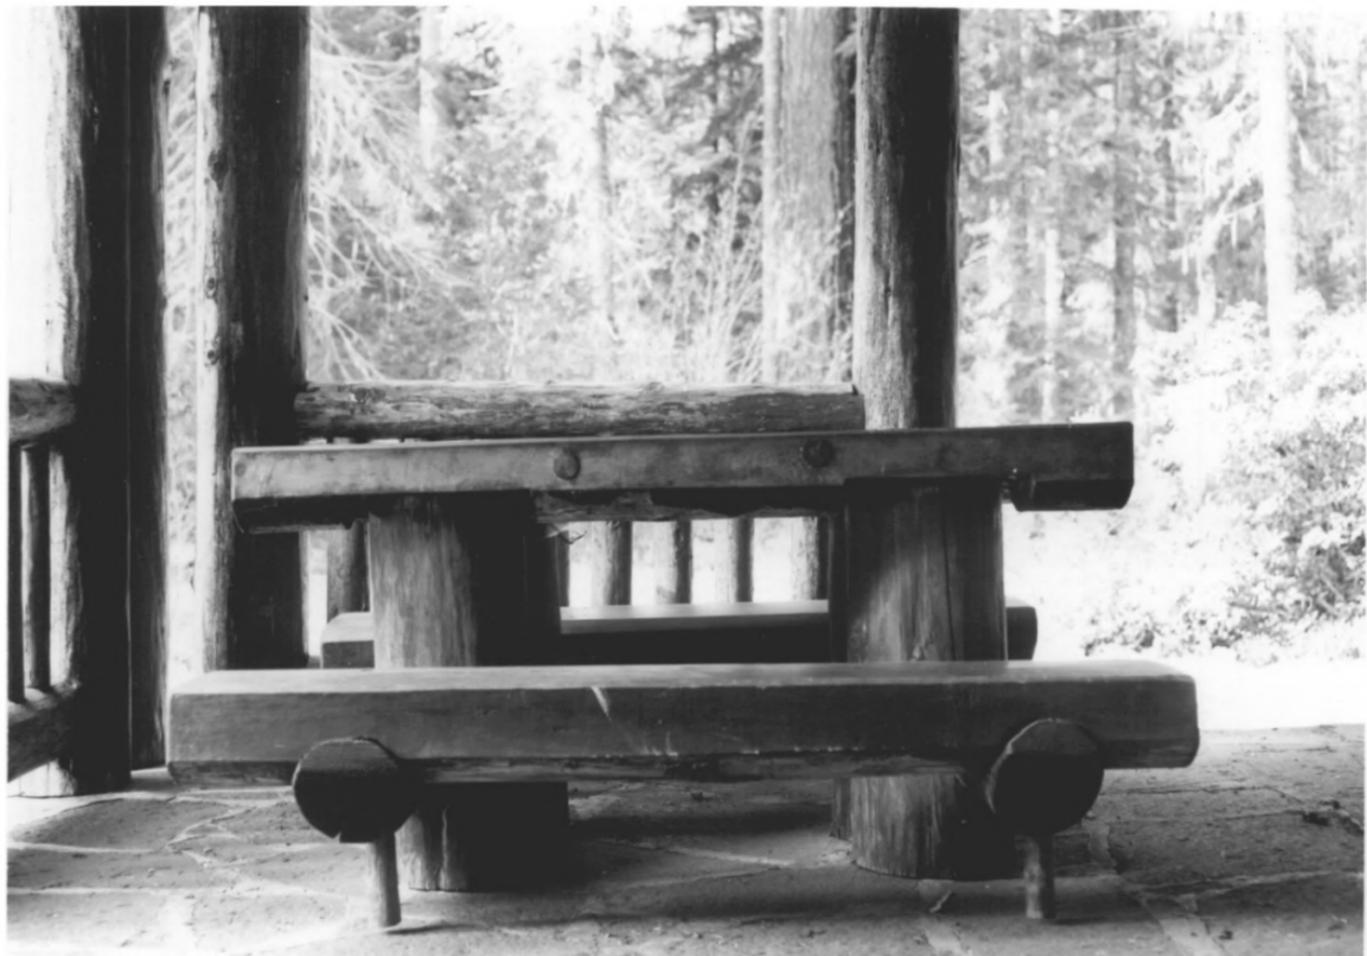
~~#46a~~ 14/50

Detail of CCC Picnic Table
Union Creek Historic District
Vicinity - Prospect, Oregon
Photographer: G.J. Throop 1/79
Negative in CRM Files - Recreation
S.O. - Rogue River National Forest
The table, one of four, is located
corner of the Community Kitchen.
is also visible.

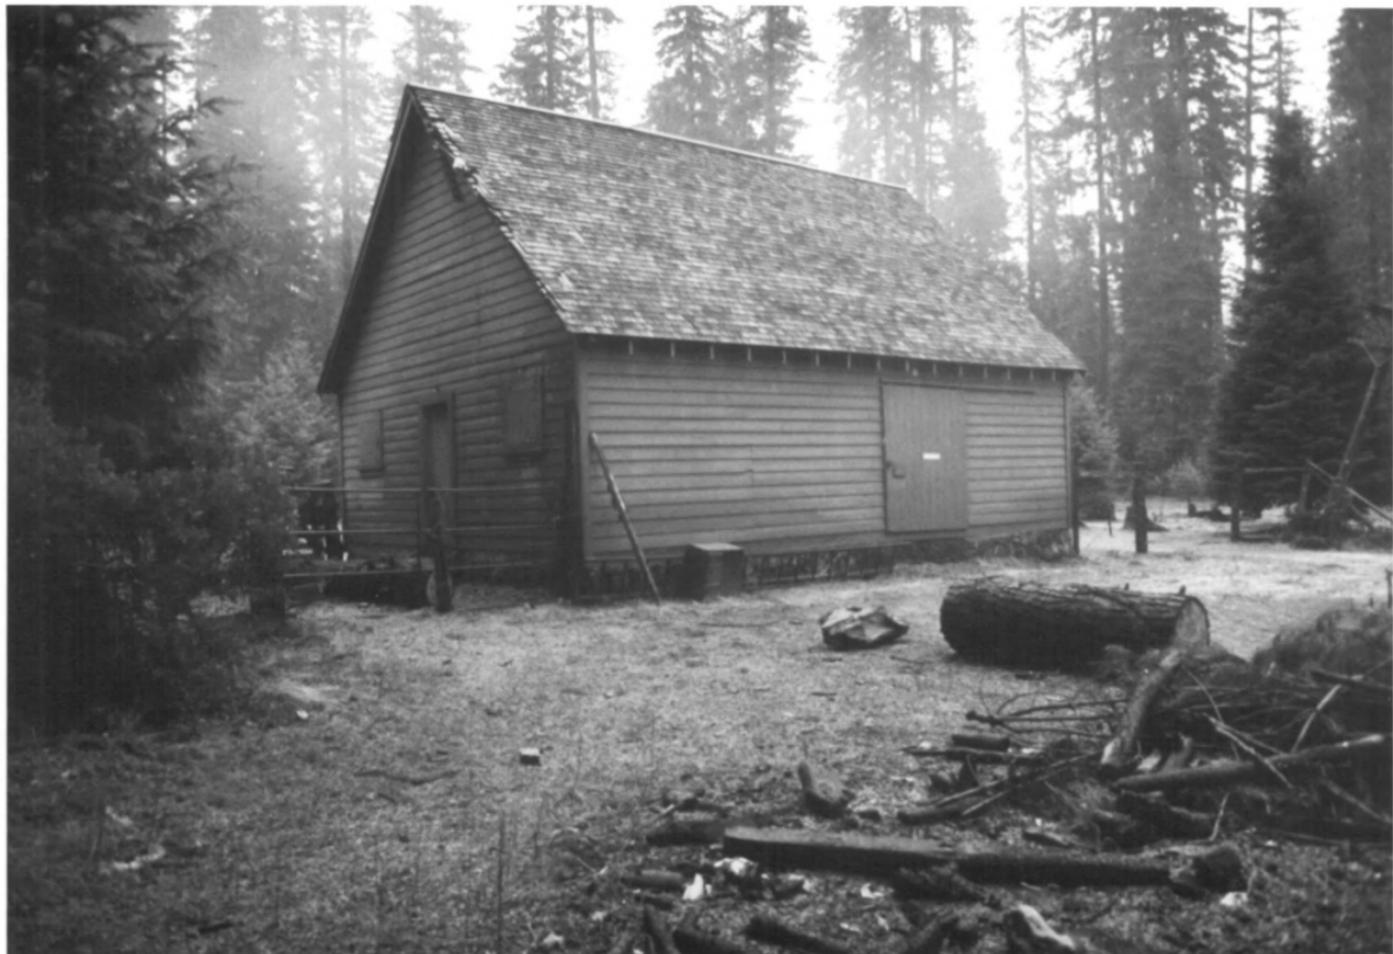
Horse Barn #2413

37. Horse Barn #2413: 1936 - CCC, rectangular, peeled-pole frame on lava rock foundation, high gable roof, exterior 1x8 wood lap siding butting to 1x4 corner trim. Three bays on east elevation open. Enclosed storage area on north end. Roof material and roof trim damaged on northwest corner, otherwise structurally and materially sound, unaltered.

Looking southeast toward the north and west elevations of the barn. Note the deterioration of the roof material and roof trim on the northwest corner.

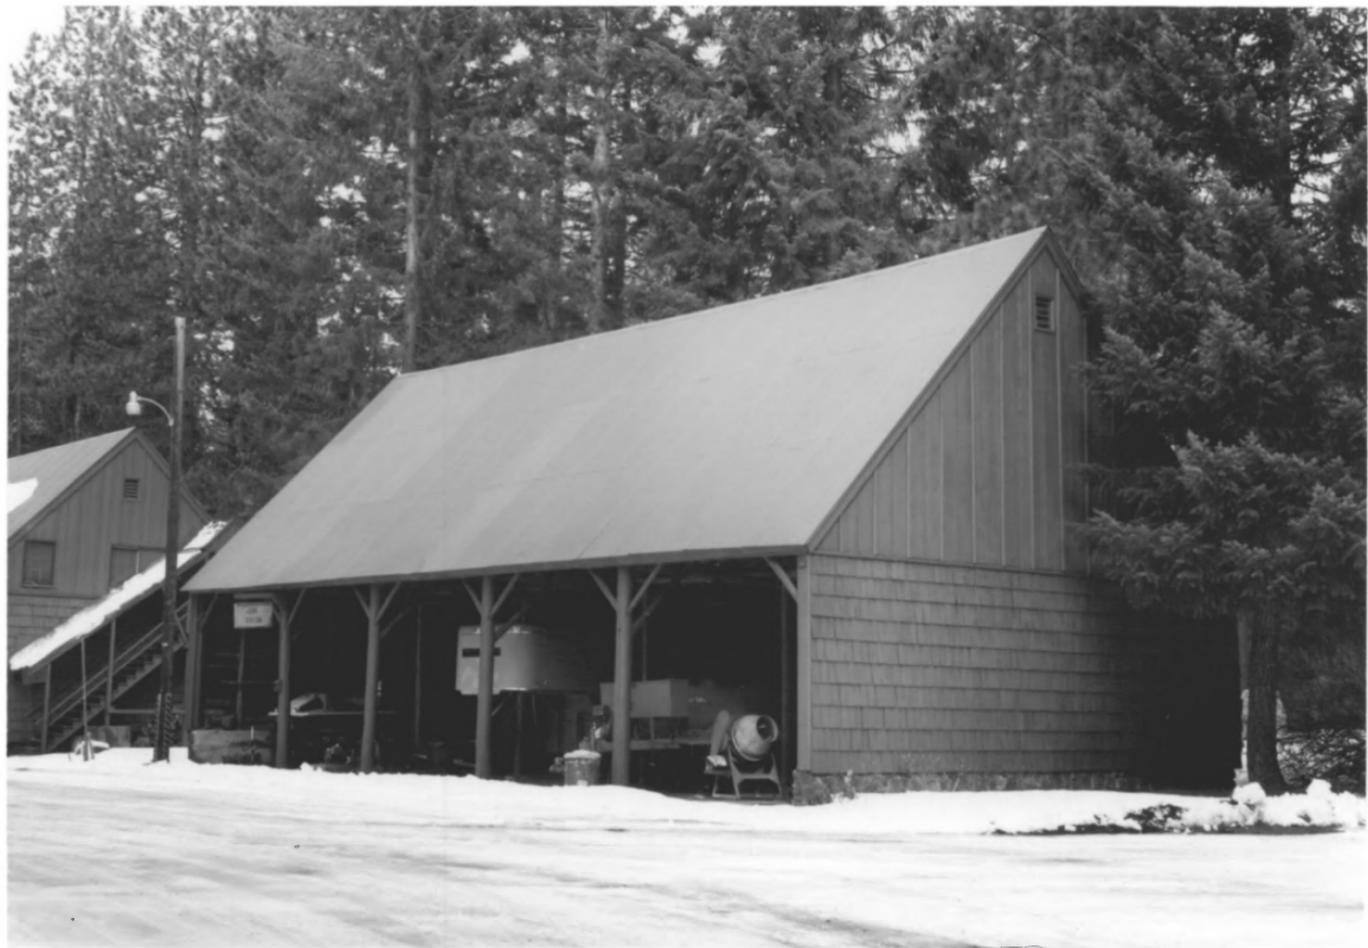
~~#39~~ 18/50

Fire Equipment Shed #2306
Union Creek Historic District
Vicinity - Prospect, Oregon
Photographer: G.J. Throop 1/79
Negative in CRM Files - Recreation
S0 - Rogue River National Forest
Looking northwest toward the east and south (main)
elevations of the shed.

39. Fire Equipment Shed #2306: 1942 - CCC, rectangular, peeled-pole framing, exterior wood shakes and vertical board and batten, high gable roof, open length of south elevation. 1962-63 wood shake roof replaced with corrugated metal. In very good condition.

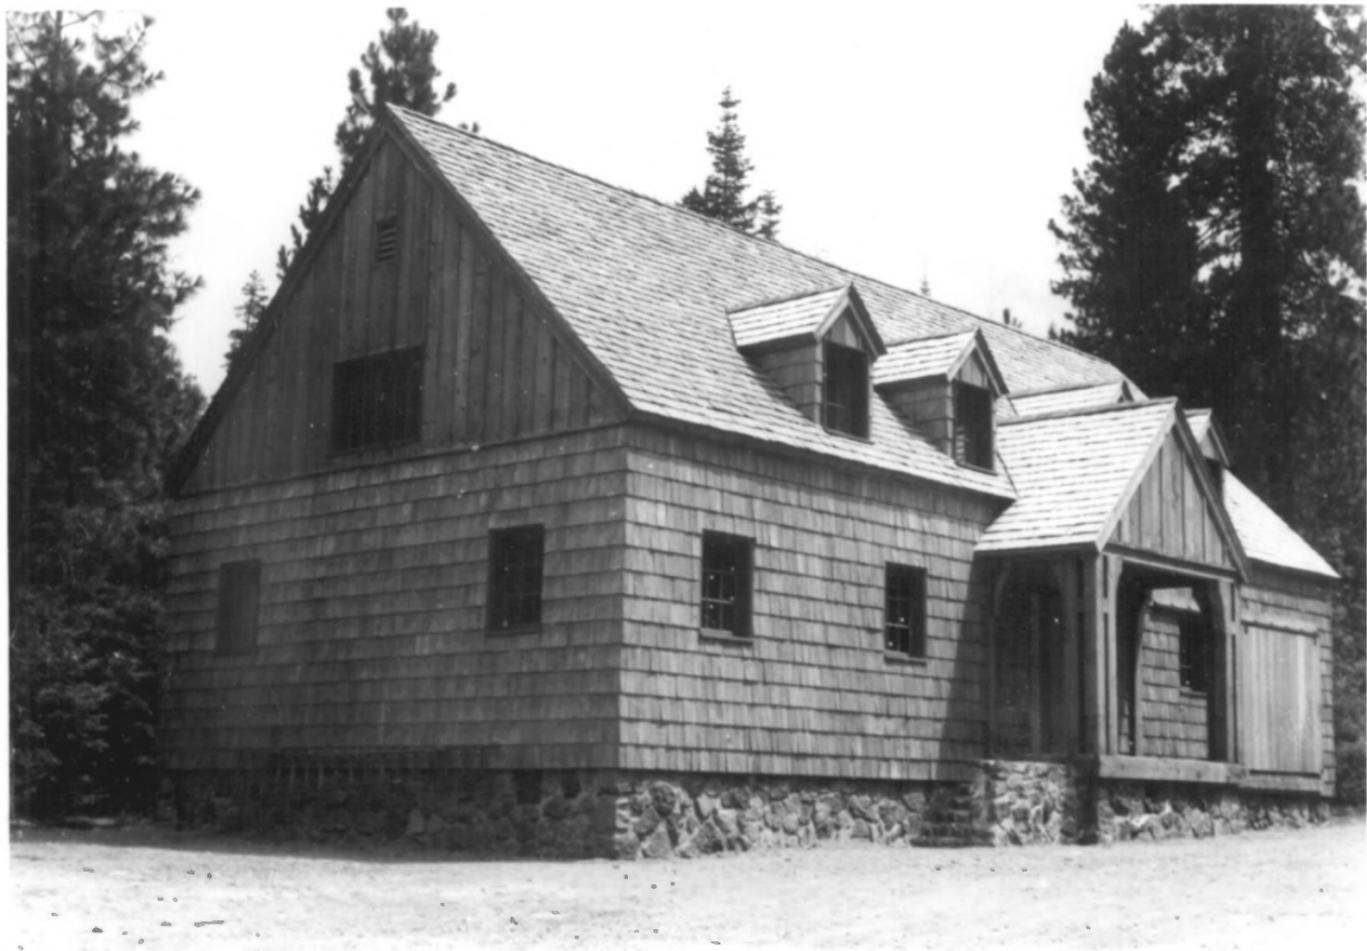
Fire Warehouse #2205 in ca. 1941
Union Creek Historic District
Vicinity - Prospect, Oregon
Photographer unknown ca. 1941
From Historic Photograph Collection
Recreation, S.O. - Rogue River NF
Catalog # Y-4-16

From southwest, looking at the west and south (main)
facades, prior to the addition of outside stairs.
Note original roof materials.

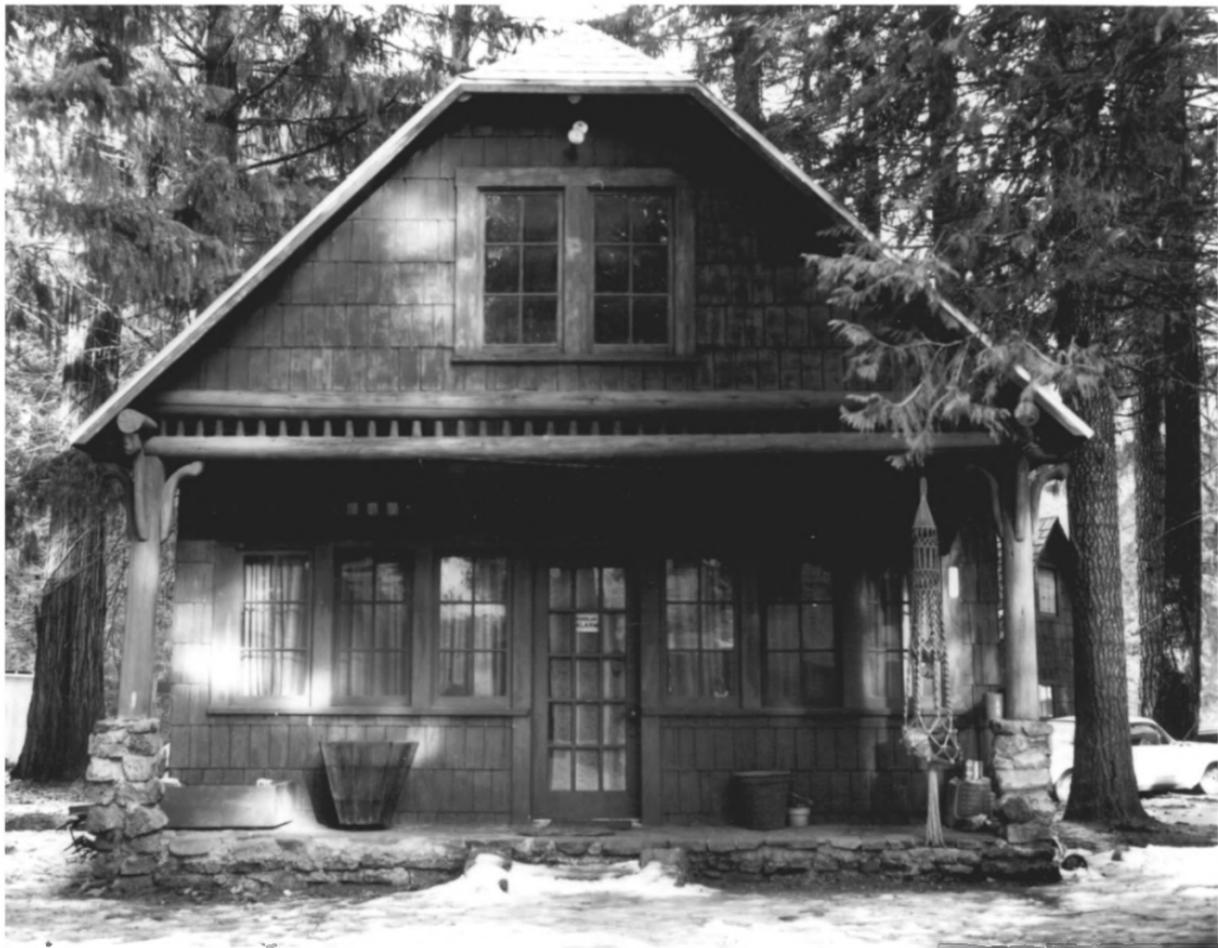
Permittee's Residence
Union Creek Historic District
Vicinity - Prospect, Oregon

Looking northwest toward the south (main) facade. The photograph shows the important architectural details of the porch construction which is very similar to that of Beckie's Cafe.

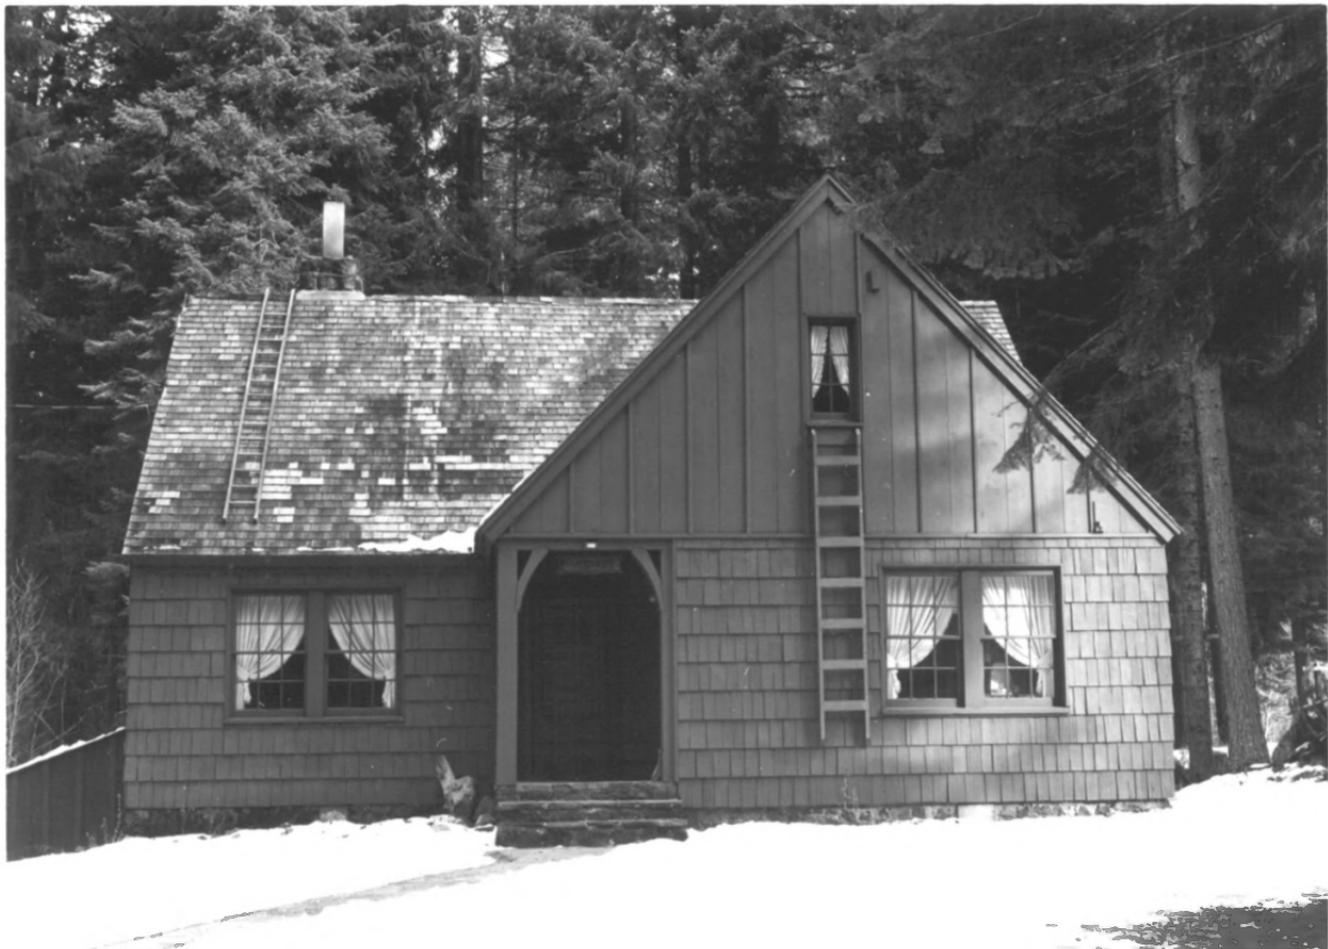
25. Small Drinking Fountain: quartzite rock.
26. Resort Picnic Area: Landscaped with indigenous vegetation and native basalt.
27. Forest Service Residence #1031: 1934 - CCC, T-shaped, wood frame structure, high hipped roof, high intersecting gable, uncoursed lava rock foundation. Exterior sawn wood shingles, multi-light sash windows, covered porches. Exterior in very good condition, altered only by addition of shed roofed lean-to storage shed.

Forest Service Residence #1031
Union Creek Historic District
Vicinity - Prospect, Oregon
Photographer: G.J. Throop 1/79
Negative in CRM Files - Recreation
S0 - Rogue River National Forest
Looking north toward the south (main) facade.

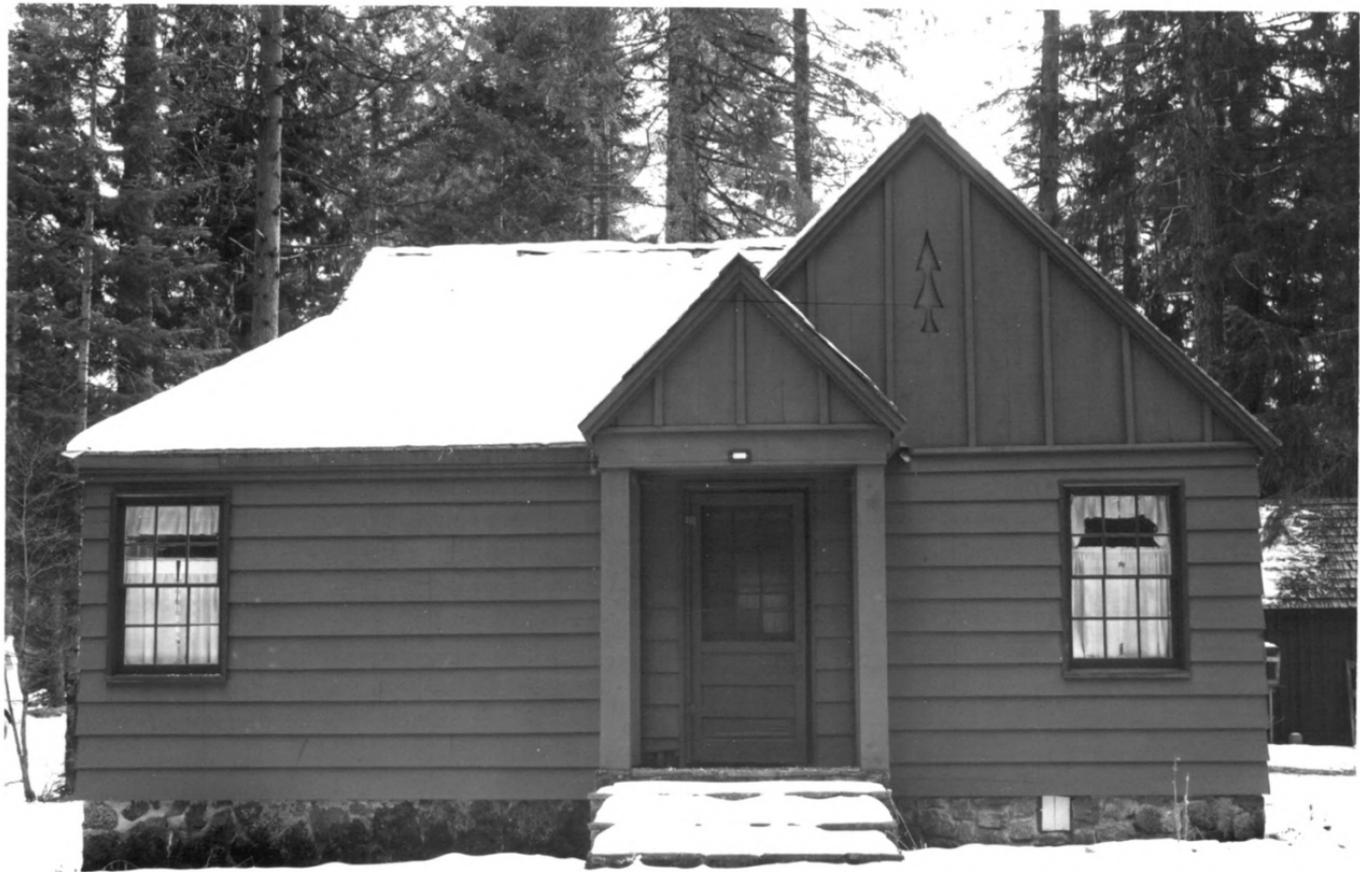
Forest Service Residence #1032

28. Garage #1529: 1935 - CCC, rectangular, detached wood frame, high gable roof, exterior board and batten and wood shingles.
29. Forest Service Residence #1032: 1940 - CCC, single story, L-shaped wood frame, lava rock foundation, hipped gable roof with gabled hip on north end. Exterior, sawn horizontal clapboards and vertical board and batten, multi-light sash windows, covered porches, pine tree logs cut out on west gable end. Exterior in very good condition. Altered only by replacement of sash window with an aluminum casement.

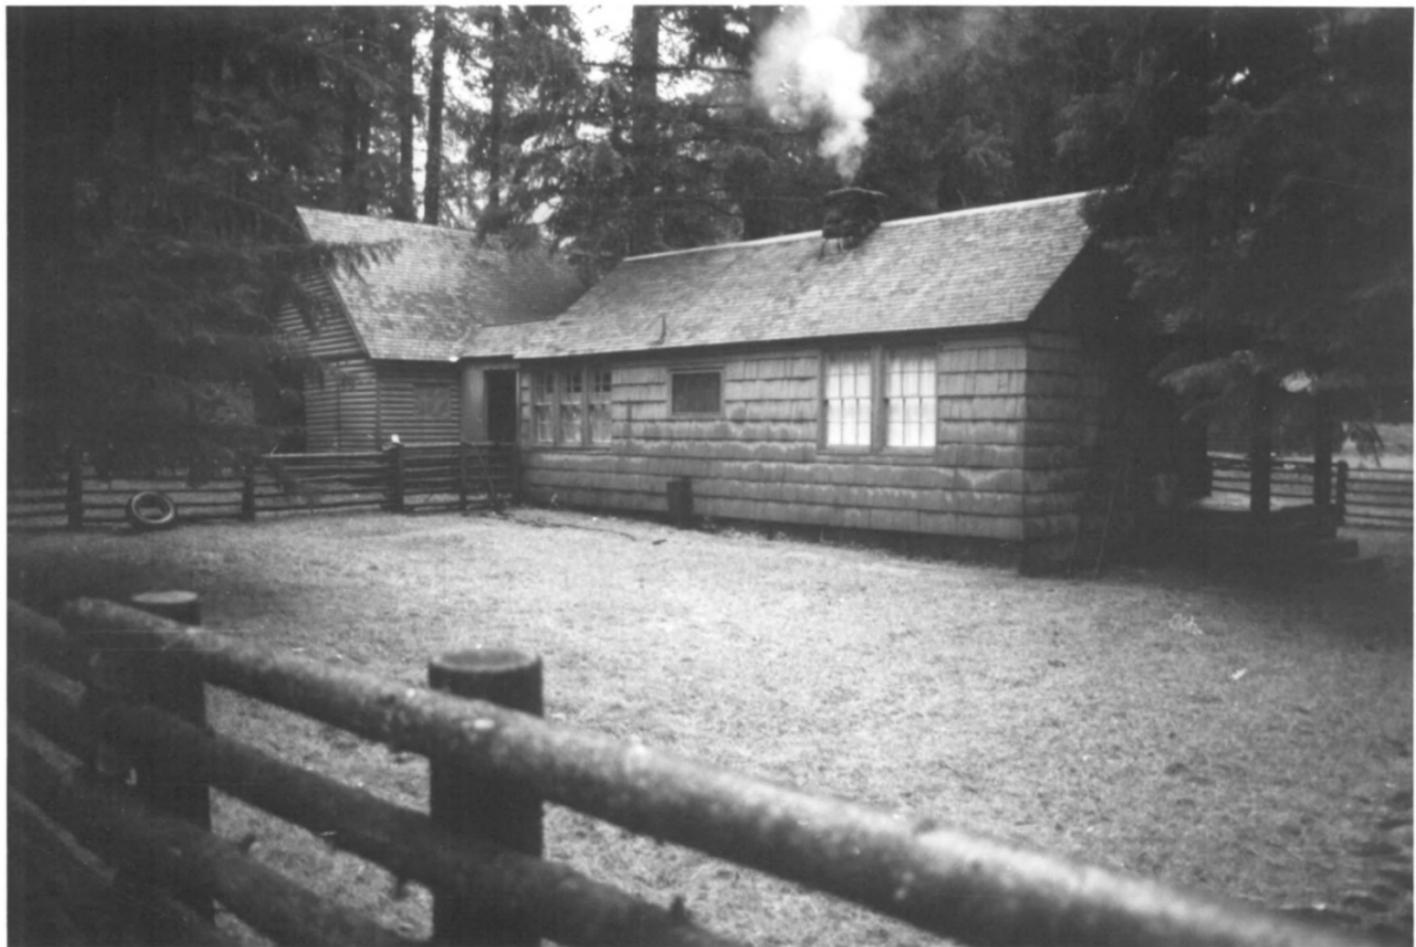
30. Garage #1528: 1935 - CCC rectangular, wood frame with high gable roof, exterior board and batten and wood shingles.
31. Forest Service Residence #1033: 1931, single-story, T-shaped, wood frame, lava rock foundation, high gable roof with cross gable. Exterior wood shingles, multi-light sash windows. Remodeled interior and exterior, 1940 by CCC, converting use from office to residence. Pine tree logos on west and south gable ends and on west porch pediment. Exterior in good condition, no obvious alteration.

Forest Service Residence #1033
Union Creek Historic District
Vicinity - Prospect, Oregon
Photographer: E.G. Throop 11/78
Negatives in CRM Files - Recreation
S0 - Rogue River National Forest

Looking southeast toward the west and north facades.
