**NATIONAL REGISTER OF HISTORIC PLACES
INVENTORY -- NOMINATION FORM**

AND/OR COMMON
Union Creek Historic District

Union Creek Historic District
Jackson County, Oregon
FEATURE LOCATION MAP

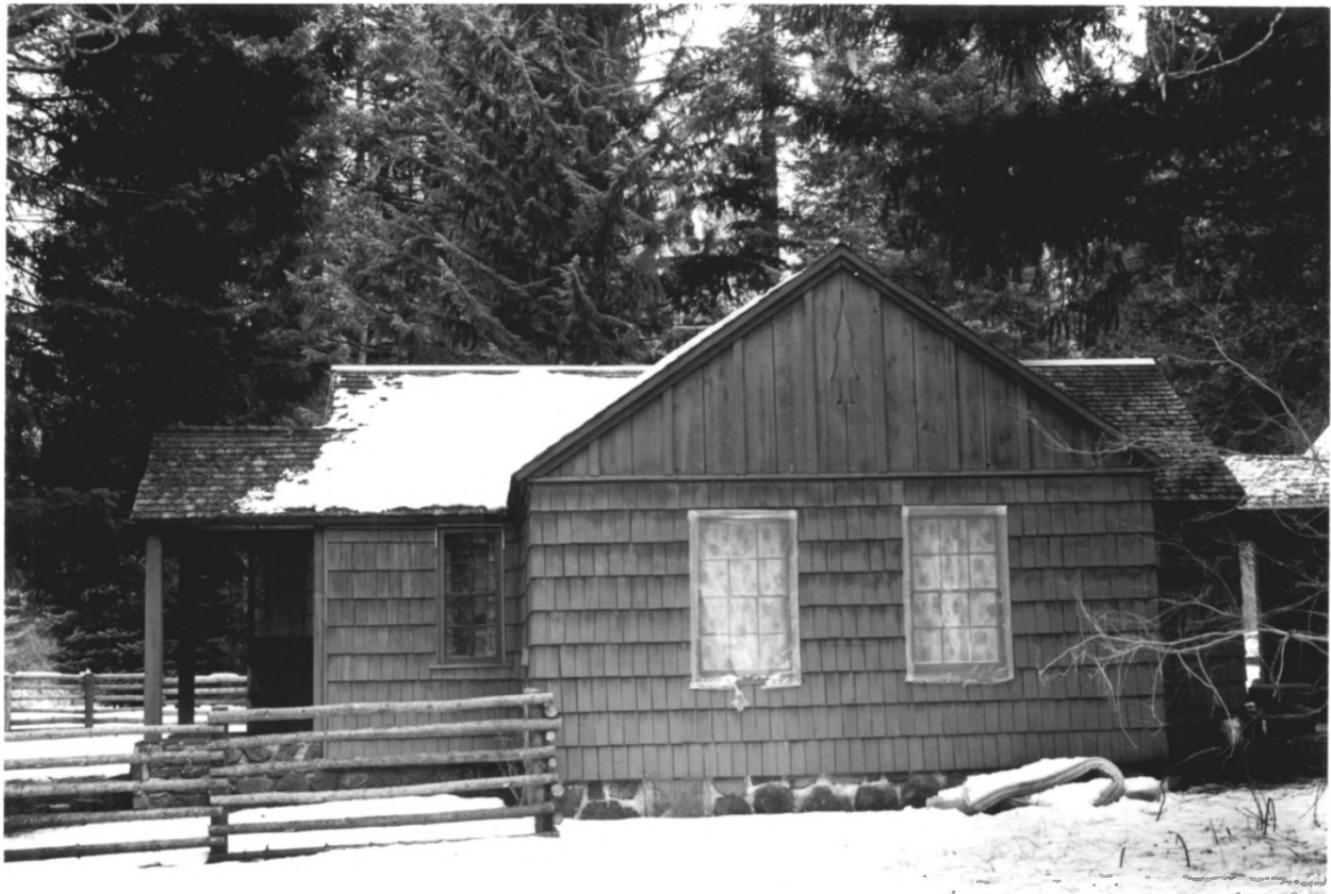
Forest Service Residence #1033
Union Creek Historic District
Vicinity - Prospect, Oregon
Photographer: G.J. Throop 1/79
Negative in CRM Files - Recreation
S0 - Rogue River National Forest

Looking north toward the cabin's south elevation. A
pine tree symbol is cut out on the gable end.

30. Garage #1528: 1935 - CCC rectangular, wood frame with high gable roof, exterior board and batten and wood shingles.
31. Forest Service Residence #1033: 1931, single-story, T-shaped, wood frame, lava rock foundation, high gable roof with cross gable. Exterior wood shingles, multi-light sash windows. Remodeled interior and exterior, 1940 by CCC, converting use from office to residence. Pine tree logos on west and south gable ends and on west porch pediment. Exterior in good condition, no obvious alteration.

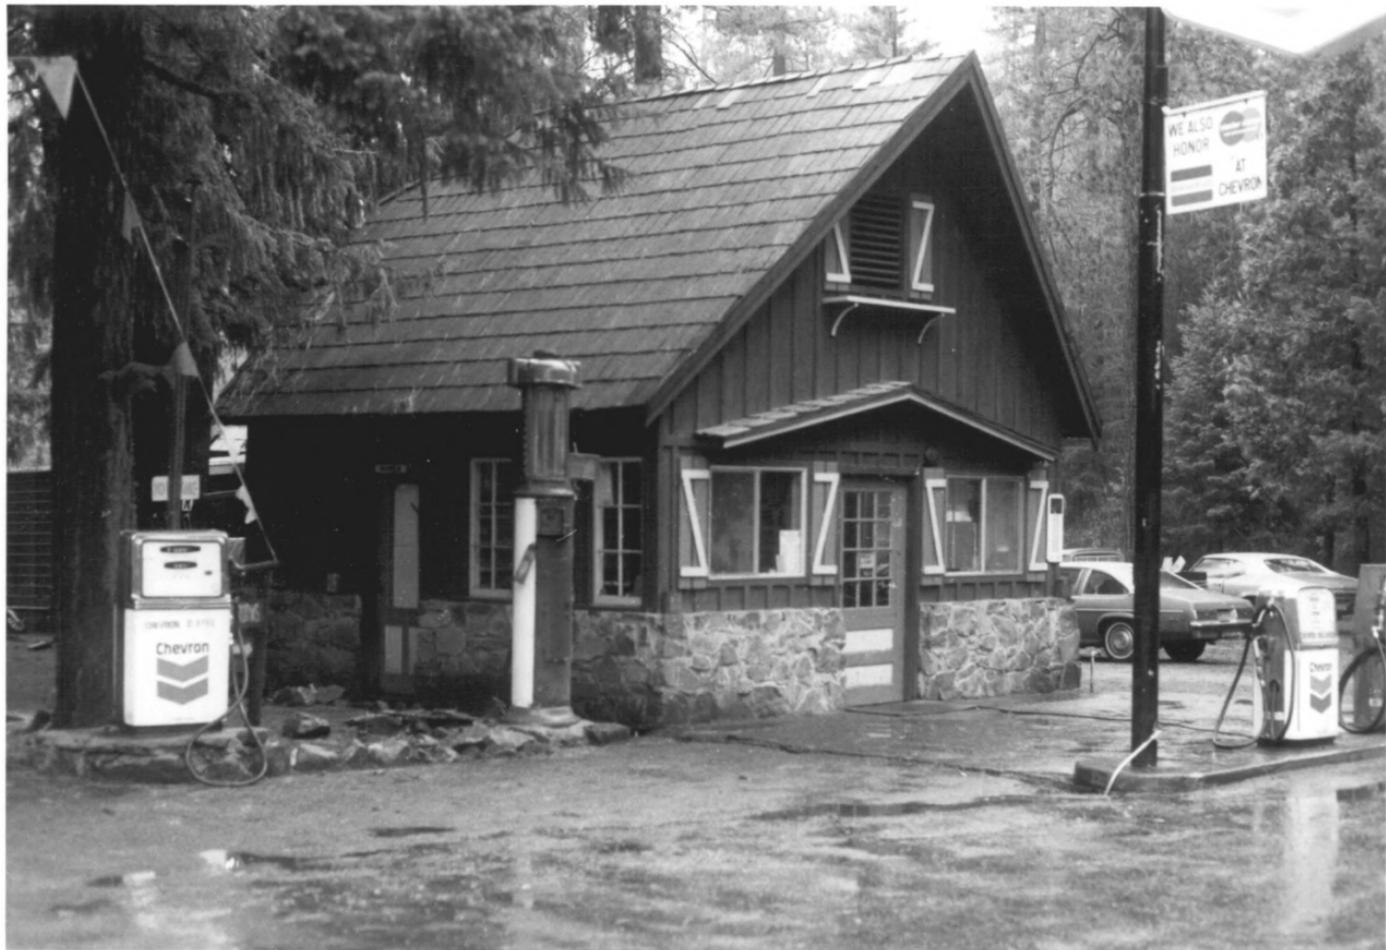
~~#19~~ 26/30

Union Creek Gas Station
Union Creek Historic District
Vicinity - Prospect, Oregon
Photographer: E.G. Throop 11/78
Negative in CRM Files - Recreation
S0 - Rogue River National Forest
Looking northwest toward the east (main) and south
facades. The photograph shows the intrusive
architectural details of the 1977 alteration.

With the exception of the Union Creek service station, the Union Creek garage, and the permittee's residence in the resort complex, exterior alteration of the historic structures has been minor. In 1977, the porch extending over the service area of the gas station was removed, the roof design modified, the exterior wall material replaced with vertical board and batten, the sash windows replaced with aluminum casements, and a "Swiss-alpine" decor added. At the same time, the main facade and the roof design of the Union Creek garage were also modified. The permittee's residence has a shed-roofed addition extending across the ground-story level of the north elevation.

19. Union Creek Service Station: 1924. Rectangular, 1-1/2 story structure, remodeled in 1933 to include a porch extending over the service area, and a modification of the roof design, the service station has a hipped gable roof, with wood shake exterior, multi-light sash windows, and ca. 1936, the addition of uncoursed lava rock to the 4-foot level on all elevations. In 1977, the service area porch was removed, and the east gable facade significantly altered by the replacement of sash windows with aluminum casements, and the addition of "Swiss-alpine" decor.

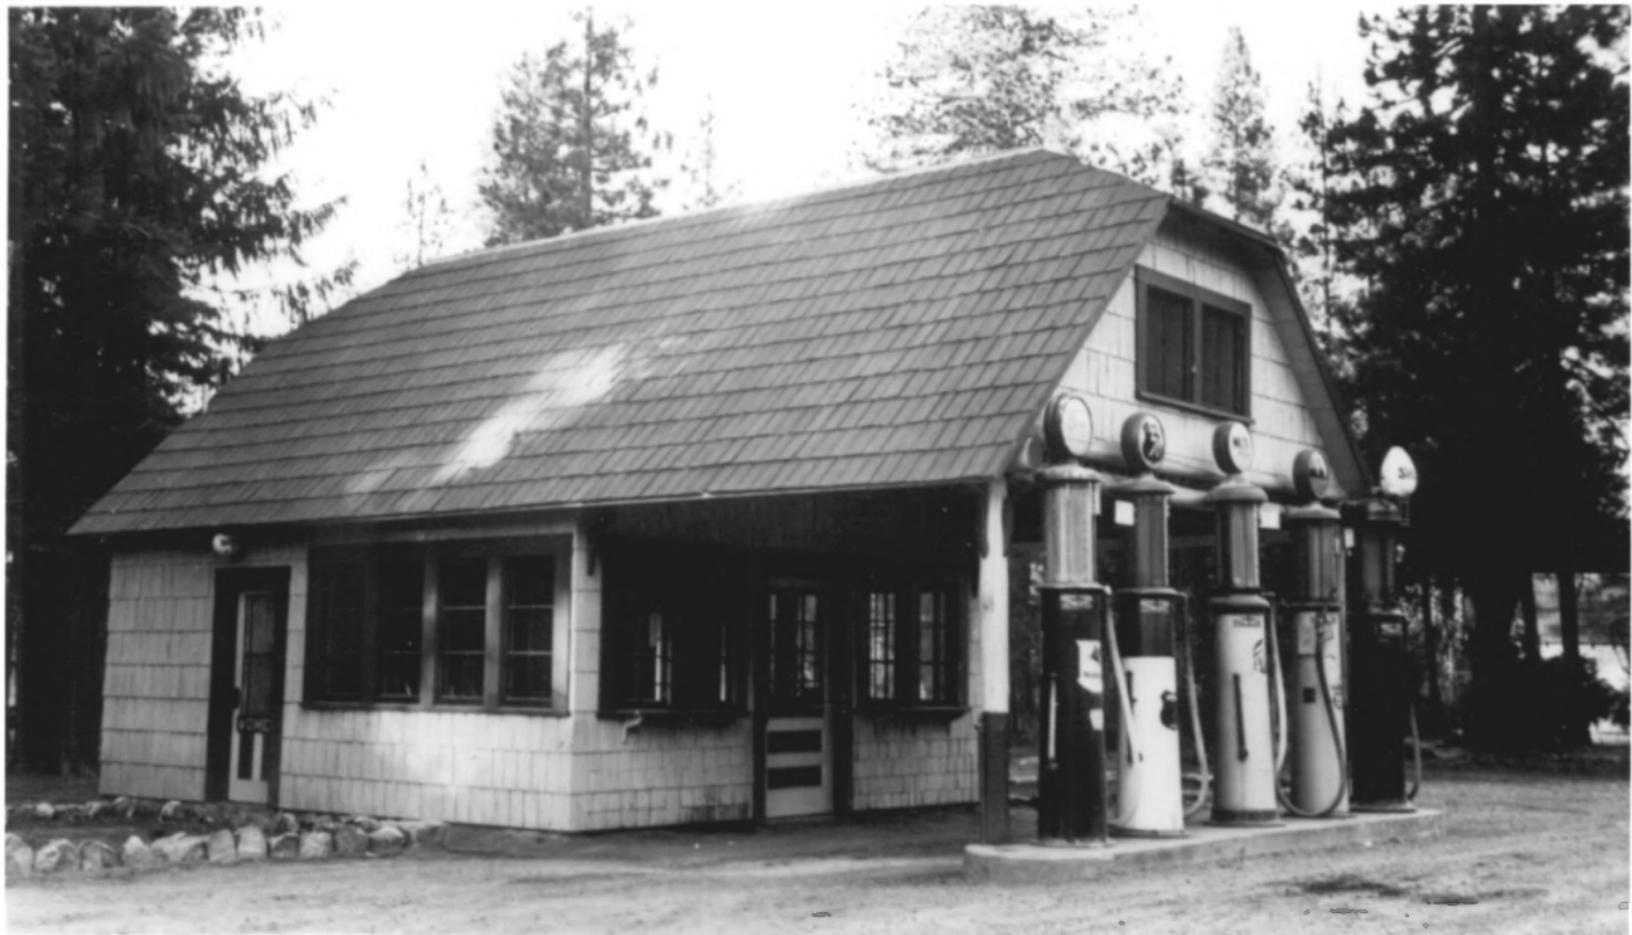
Becklehymer's Service Station in ca. 1936
Union Creek Historic District
Vicinity - Prospect, Oregon
Photographer unknown ca. 1936
From Historic Photograph Collection
Recreation, SO - Rogue River NF
Catalog # Y-2-51

Looking northwest from Crater Lake Highway, the Service
Station appears as it did after remodeling in ca.
1933. Note stonework is not yet in place

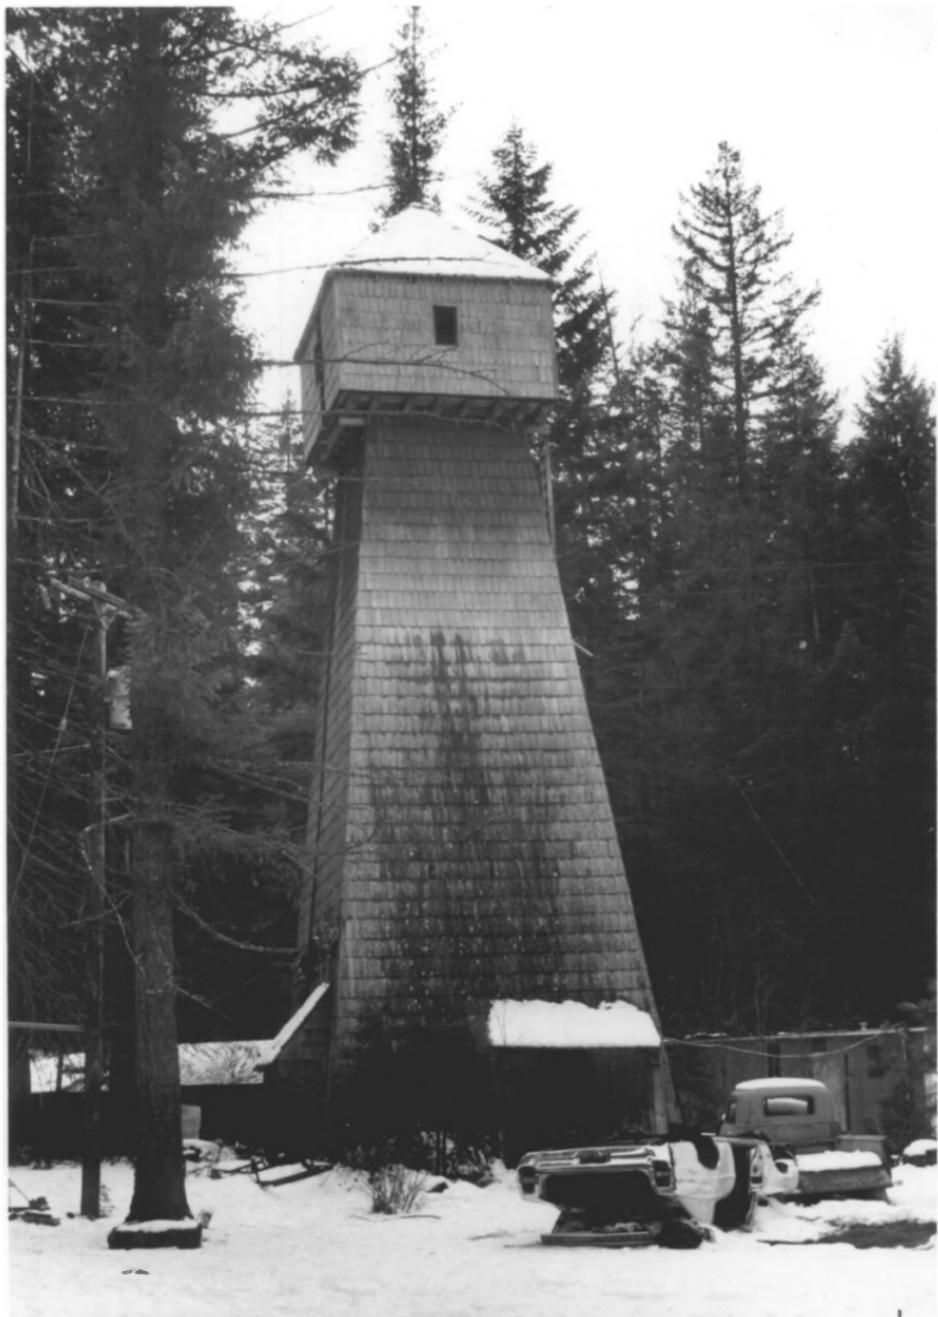
Water Tower
Union Creek Historic District
Vicinity - Prospect, Oregon
Photographer: G.J. Throop 1/79
Negative in CRM Files - Recreation
S0 - Rogue River National Forest

Looking south toward the north elevation of the water tower. The photograph shows the structural elements of the cabin atop the tower.

The quality of design, construction and workmanship among the architectural features of the Historic District are apparent. Maintenance has been regular and all major structures, except the water tower in the resort complex, are structurally sound, although some material deterioration is evident. In general, the structures are in very good condition. All are used for their originally intended purposes.

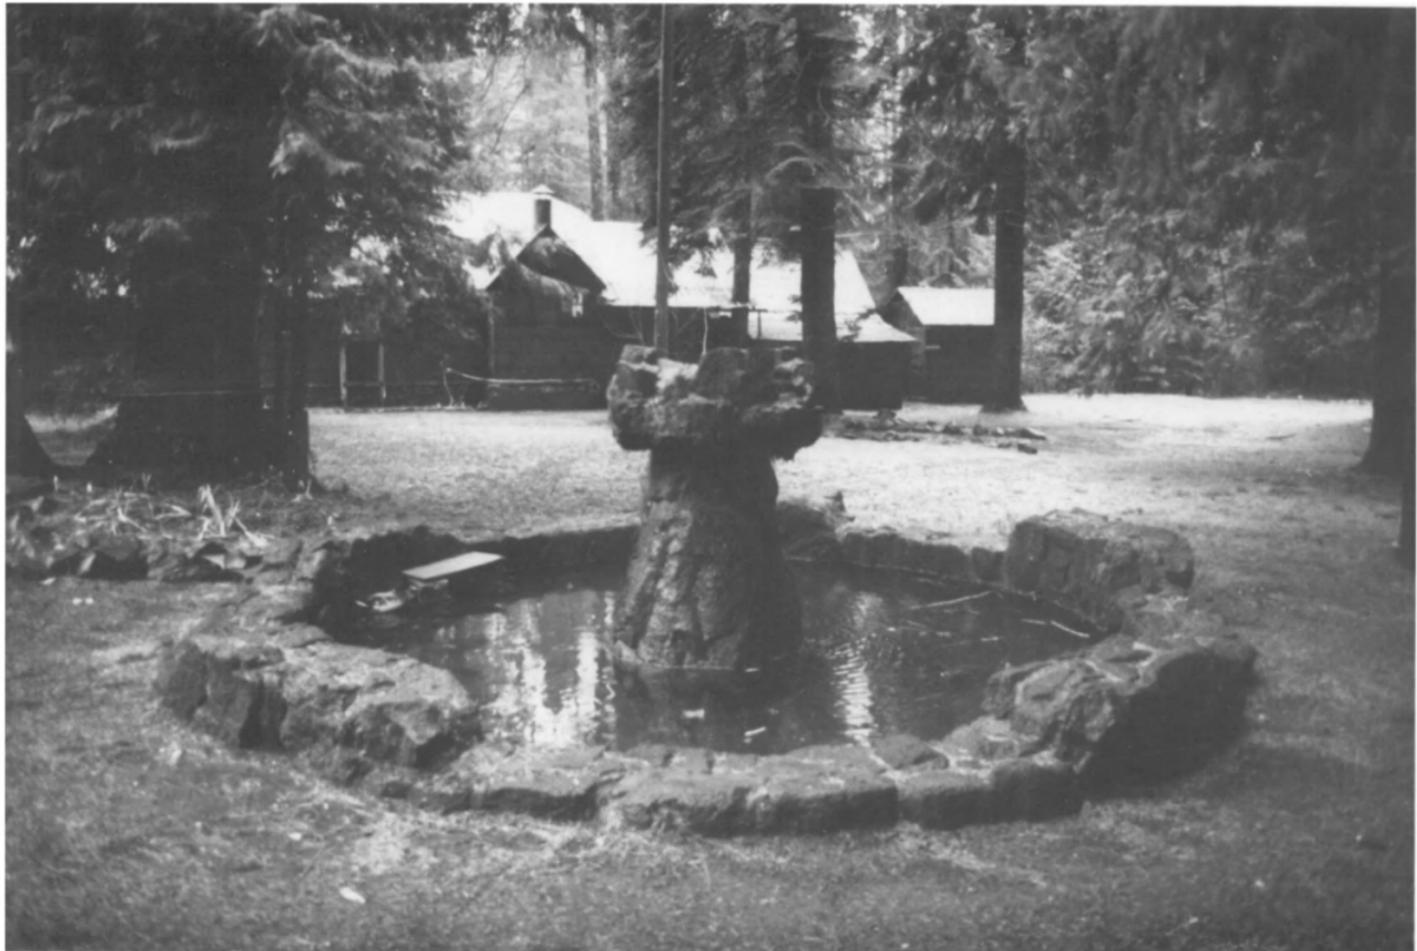
Water Fountain and Reflecting Pool
Union Creek Historic District
Vicinity - Prospect, Oregon
Photographer: E.G. Throop 11/78
Negative in CRM Files - Recreation
S0 - Rogue River National Forest

Looking southwest toward the lavastone water fountain
and reflecting pool adjacent to Beckie's Cafe on the
north.

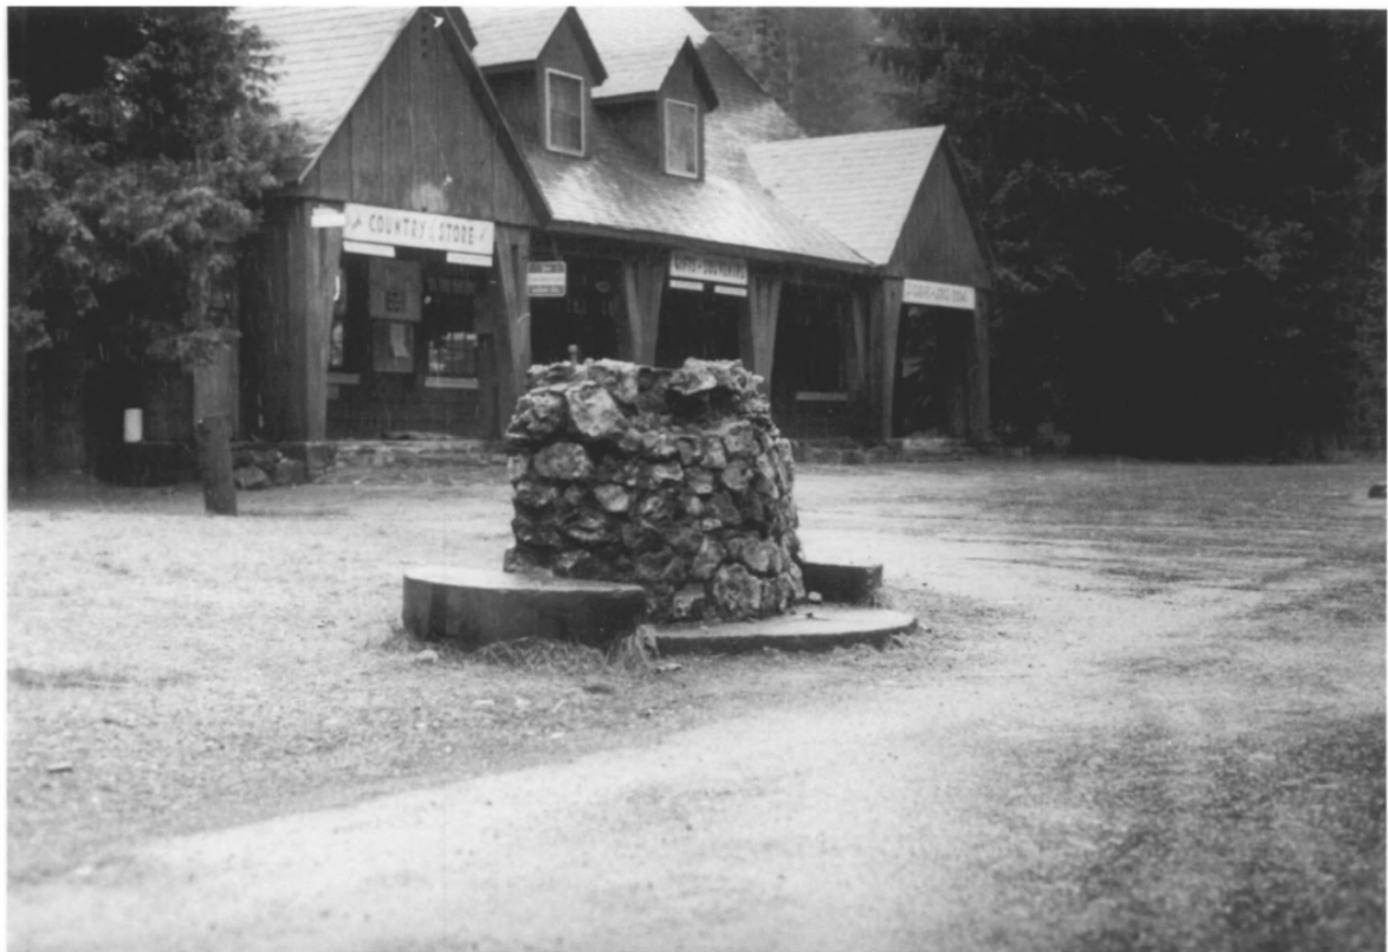
Stone Drinking Fountain
Union Creek Historic District
Vicinity - Prospect, Oregon

Looking southeast toward the north and west sides of
the fountain. The photograph shows the relationship
of the fountain to the Lodge, and damage to the
fountain.

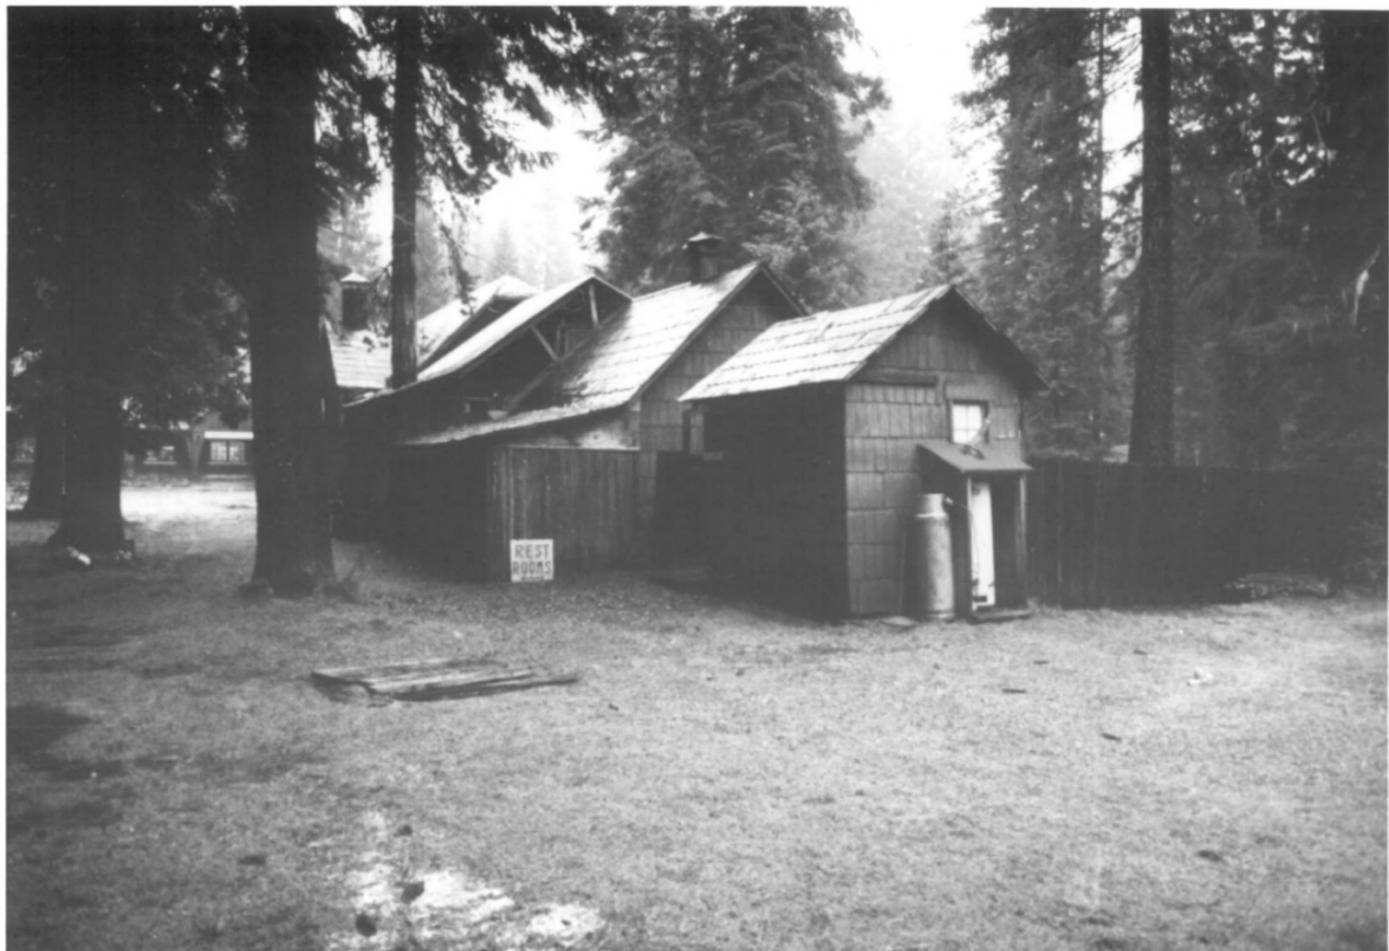
Beckie's Cafe
Union Creek Historic District
Vicinity - Prospect, Oregon
Photographer: E.G. Throop 11/78
Negative in CRM Files - Recreation
S0 - Rogue River National Forest

Looking southeast toward the west (rear) facade. The photograph shows the variations in the roofline resulting from additions and alterations to the Cafe. The separate structure in the center right is the exterior toilet facility.

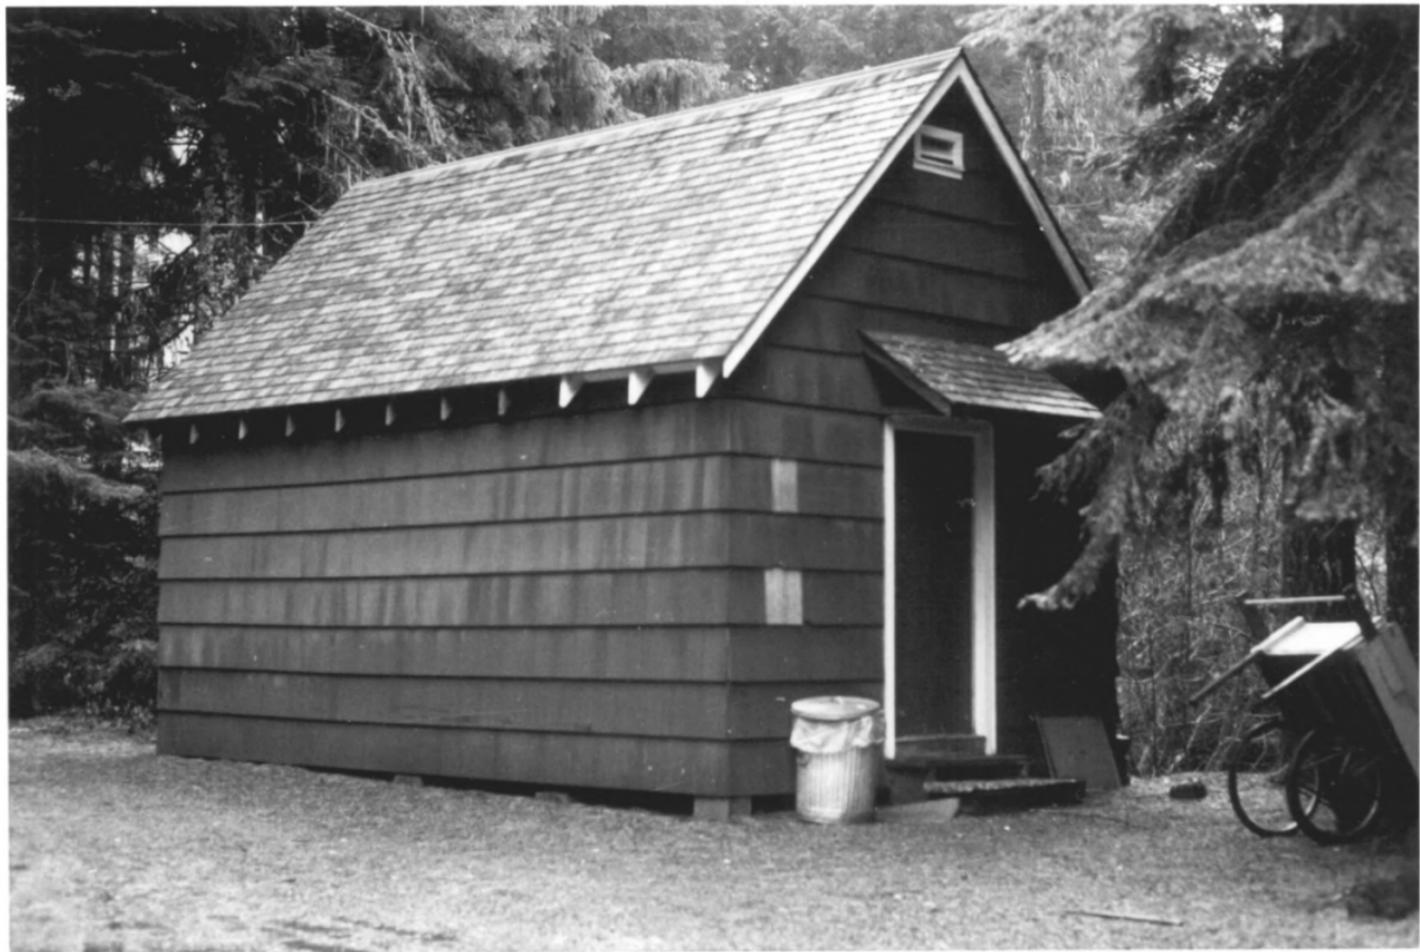
Linen Storage Building
Union Creek Historic District
Vicinity - Prospect, Oregon
Photographer: E.G. Throop 11/78
Negative in CRM Files - Recreation
S0 - Rogue River National Forest
Looking southeast toward west (main) and north facades
of the Linen Storage Building.

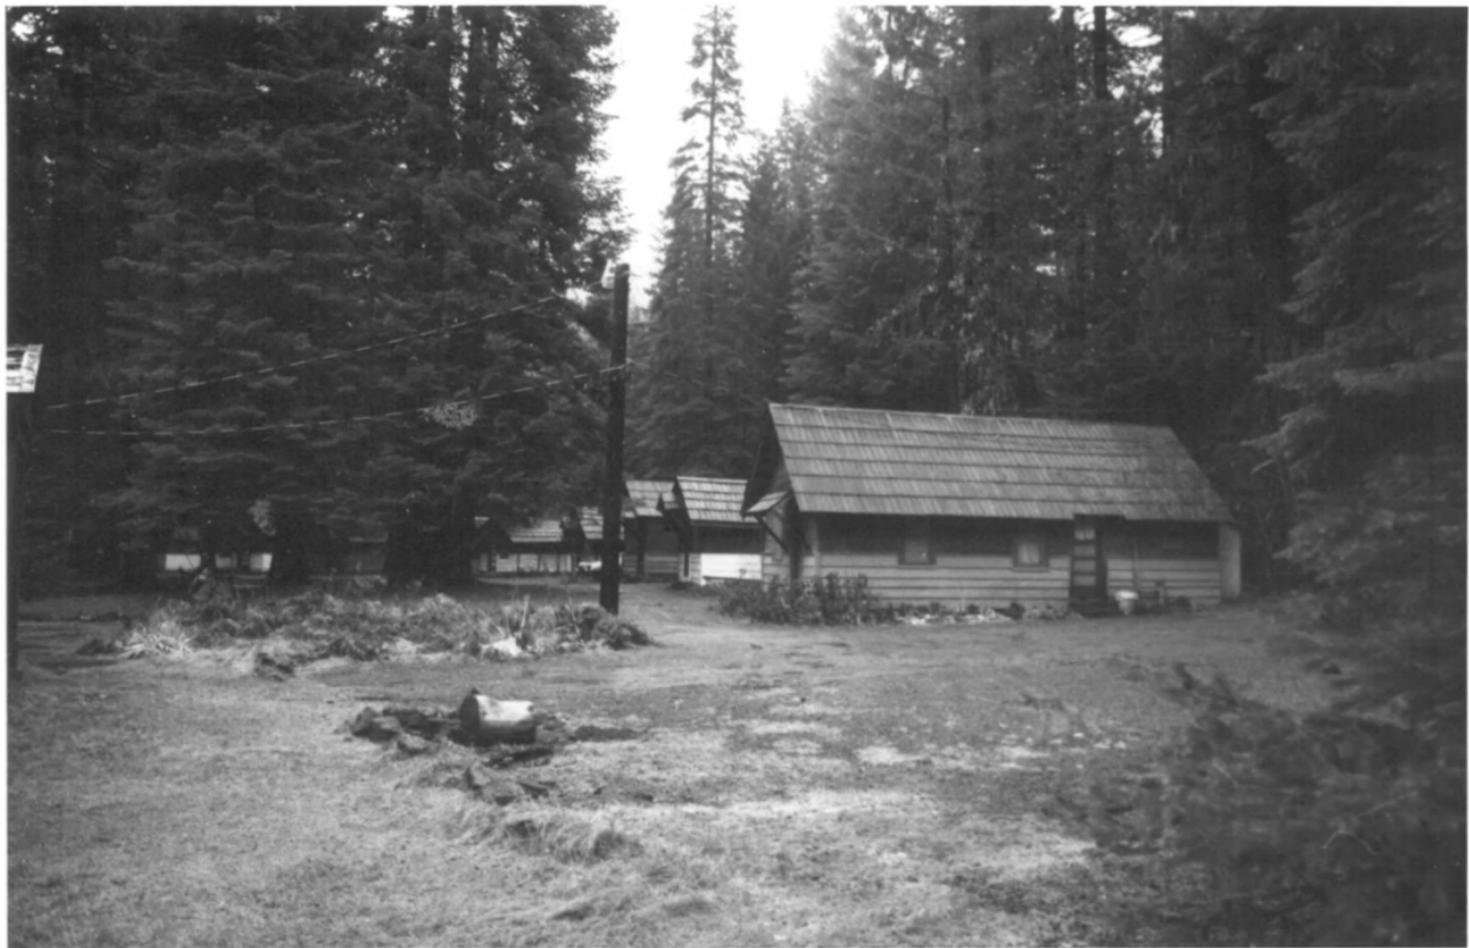
Resort Cabins
Union Creek Historic District
Vicinity - Prospect, Oregon
Photographer: E.G. Throop 11/78
Negative in CRM Files - Recreation
S0 - Rogue River National Forest
Looking north toward resort cabins aligned along the
semi-circular entry road.

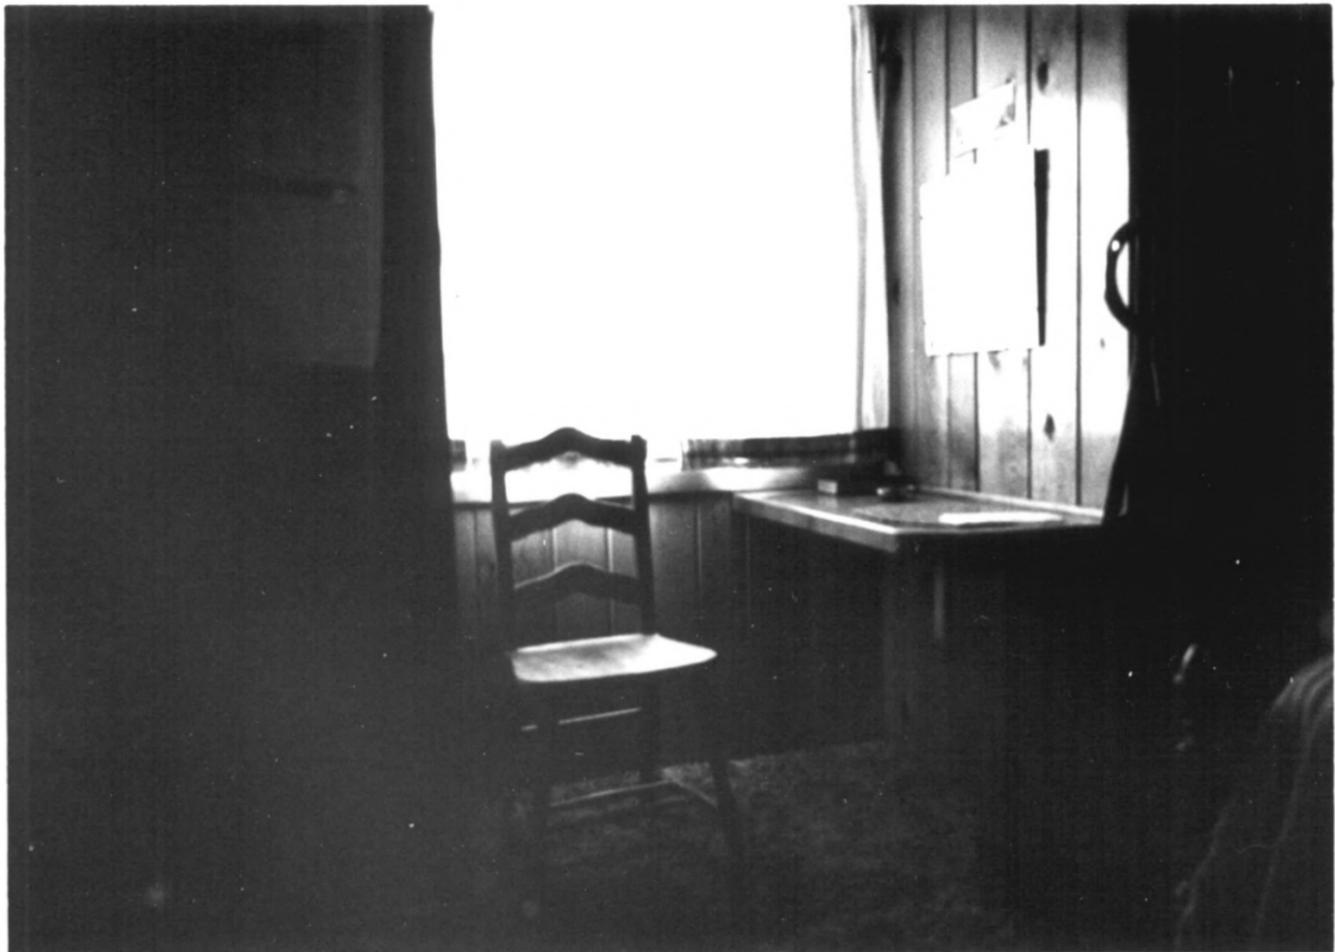
Union Creek Lodge
Union Creek Historic District
Vicinity - Prospect, Oregon
Photograph: E.G. Throop 12/78
Negative in CRM Files - Recreation
SO - Rogue River National Forest
Interior photograph looking east toward a dormer
alcove with a built-in knotty pine writing desk
in one of the upstairs guest rooms.

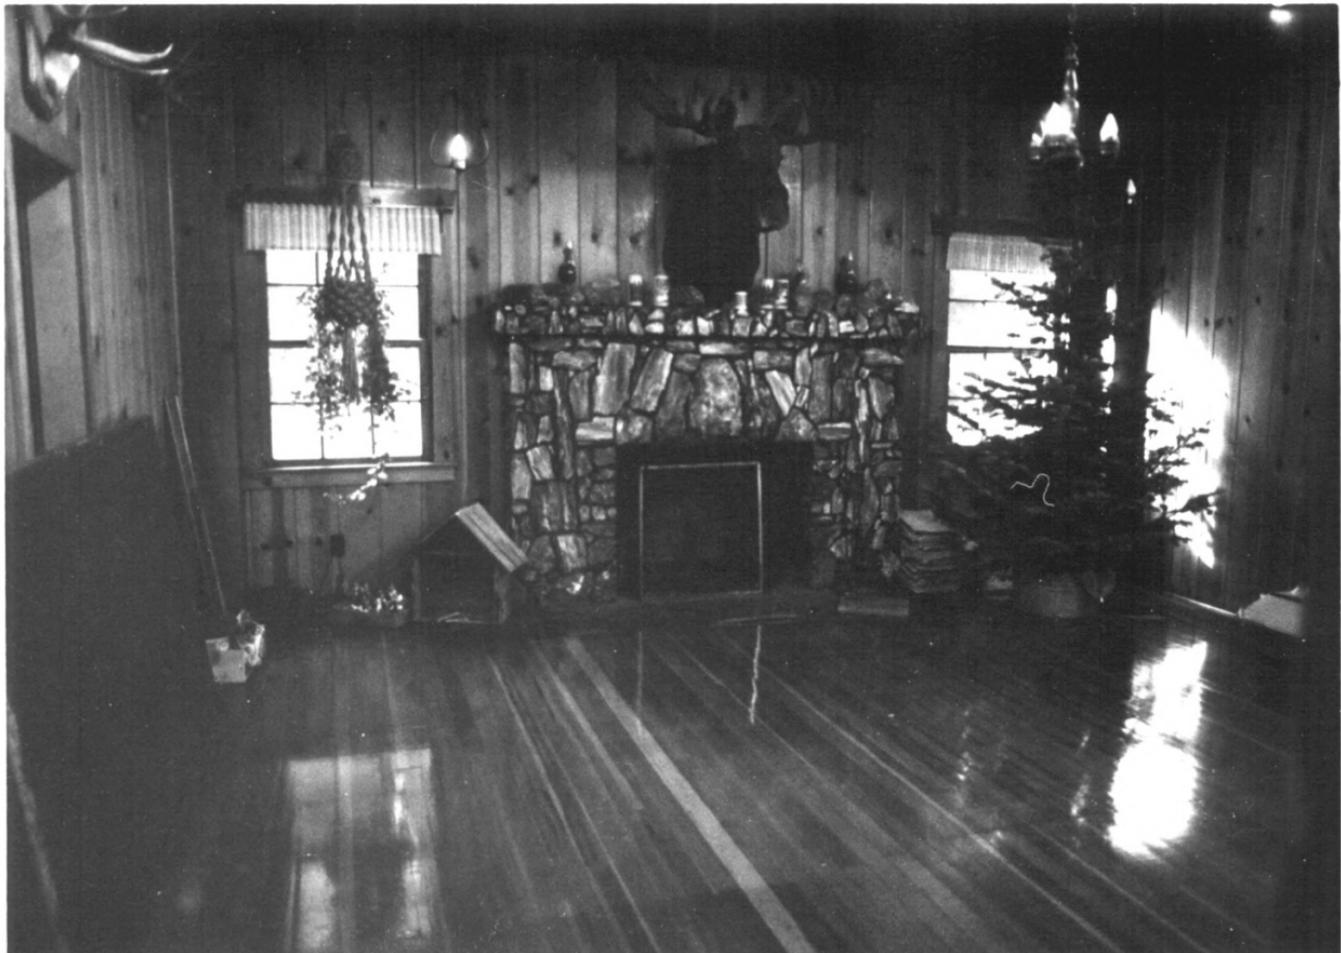
Union Creek Lodge
Union Creek Historic District
Vicinity - Prospect, Oregon
Photographer: E.G. Throop 12/78
Negative in CRM Files - Recreation
S0 - Rogue River National Forest

Interior photograph looking toward the inlaid petrified
wood fireplace located on the south wall of the Lodge
lobby. The photograph also shows the wall and floor
materials, and two of the original lighting fixtures.

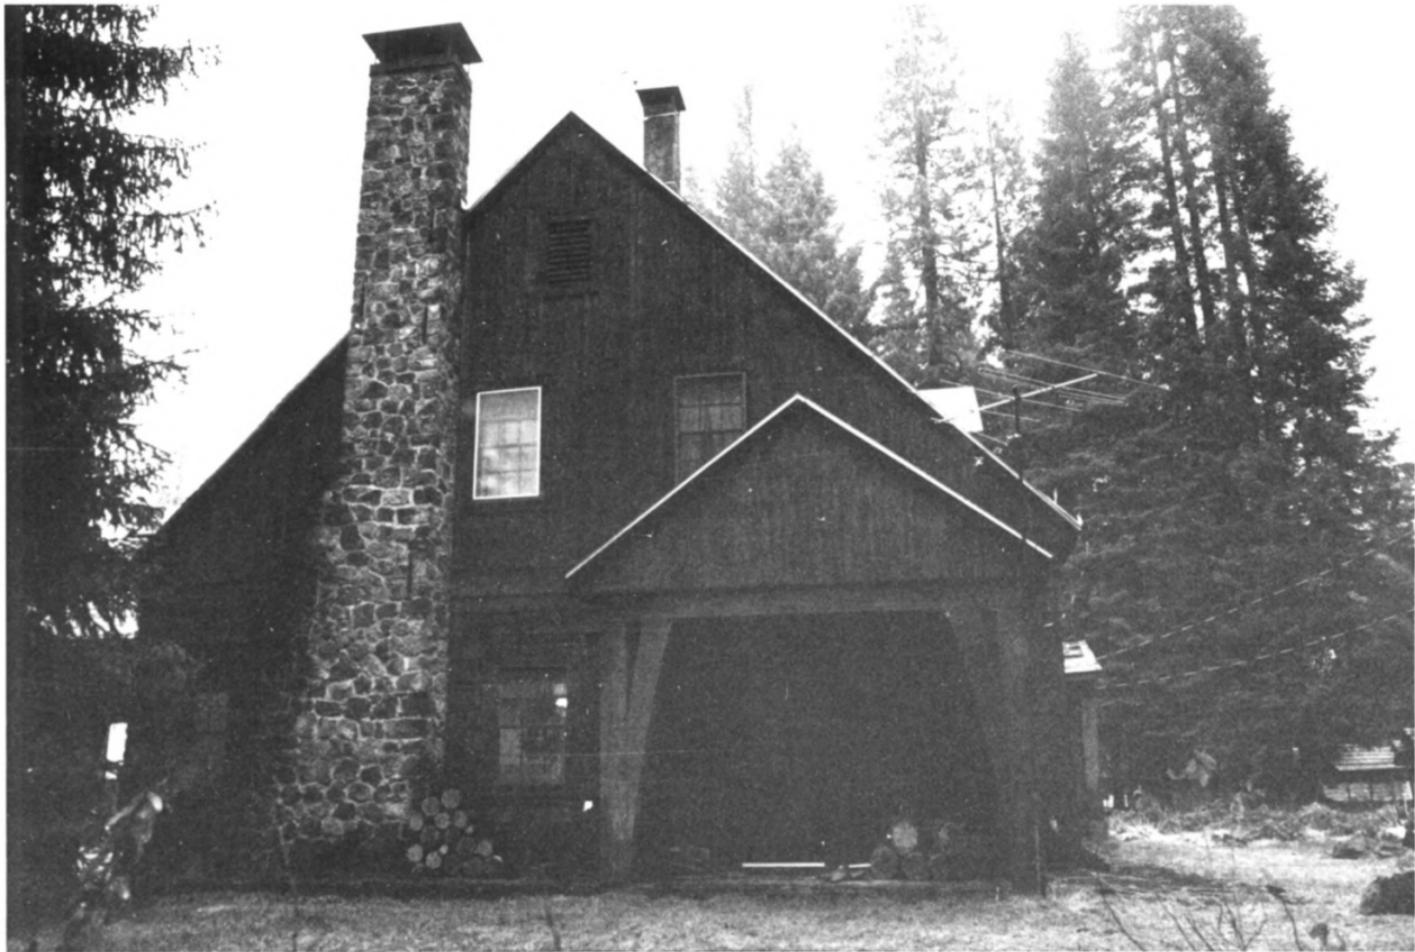
Union Creek Lodge
Union Creek Historic District
Vicinity - Prospect, Oregon
Photographer: E.G. Throop 11/78
Negative in CRM Files - Recreation
S0 - Rogue River National Forest
Looking north toward the south facade of the Lodge.
The photograph shows the exterior stone chimney.

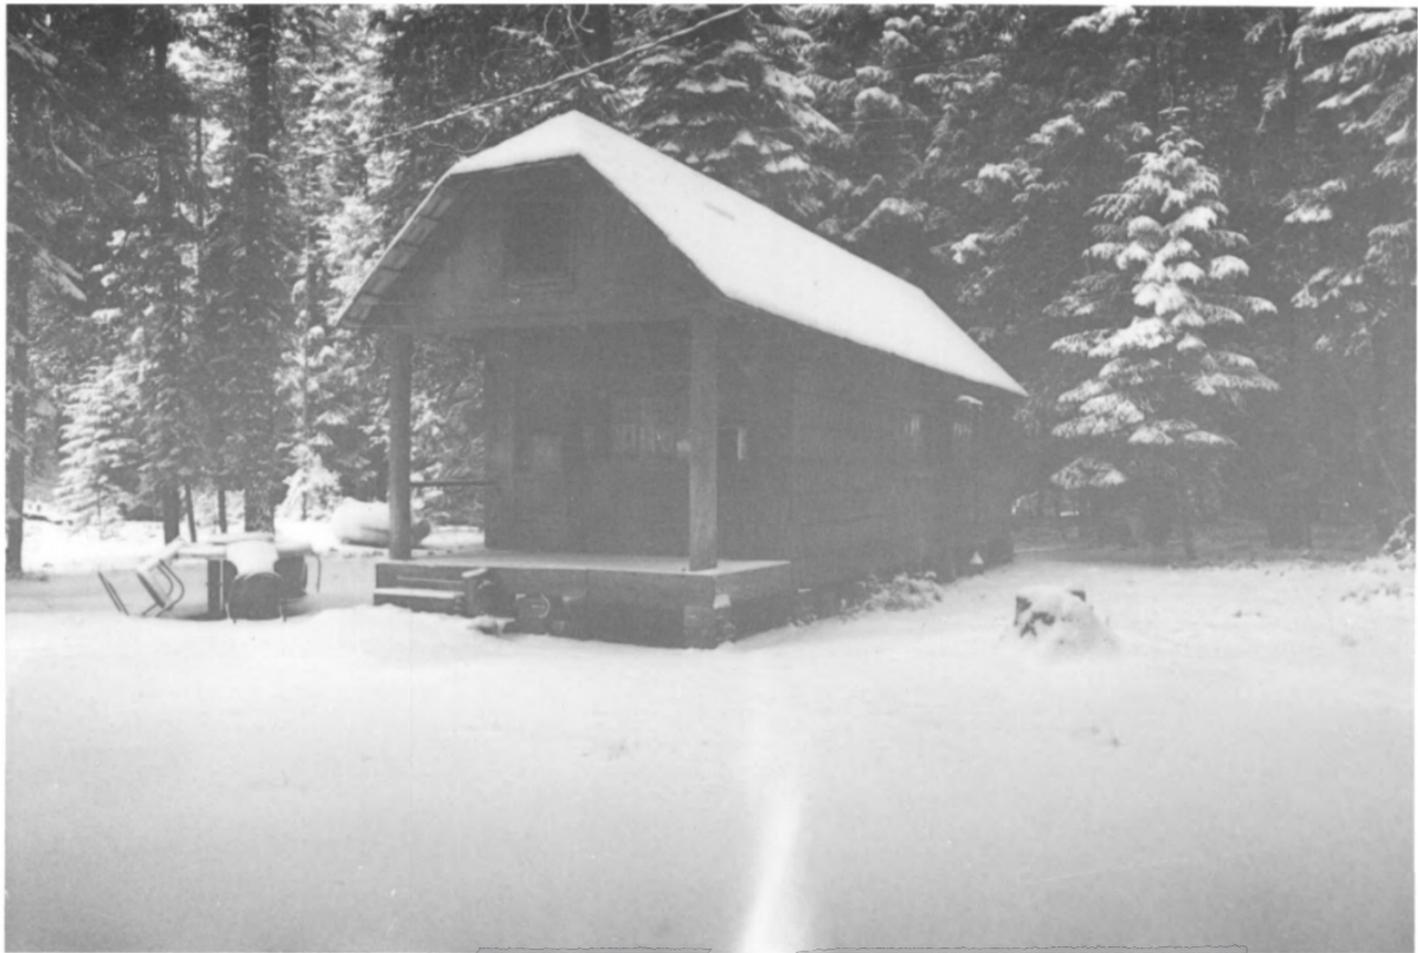
Summer Home - Block E: Representative

53. Tract of Summer Homes, Block E: 1940-1950, private ownership. Tract of 6 homes, paralleling Highway 62 on the east. Typically 1- or 1-1/2 story wood frame cabins, gable roofs, exteriors wood shakes, shingles, lapped siding. Exteriors in good condition.
